TECHNICAL REPORT

2025 Traffic Signal Assessment Updates

Town of Tecumseh

PBX Engineering Ltd.

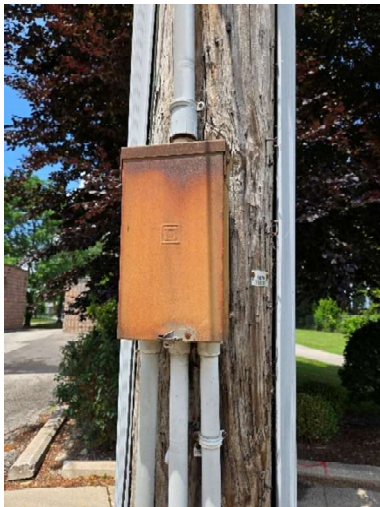
Figure 2: Power Supply Cabinet

- The pedestrian signal heads require the LED modules to be replaced due to several LEDs being burnt out.
- The pedestrian pads on the pedestrian push buttons are worn and the paint on the housing is peeling; however, they are still operating.
- The detector loops are still functioning; however, are past the end of their normal life.
- The power supply cabinet should be replaced as it is showing signs of corrosion (Figure 2).

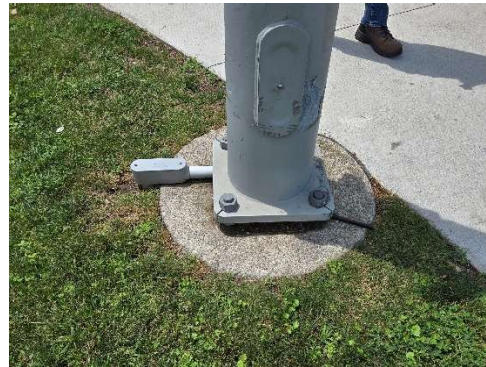
Figure 3: External Conduit

- Pole base on the SW corner has an external conduit entering from the top of the base, it is assumed that there may be damage to the conduits entering the pole base (Figure 3).
- The poles at this intersection appear to be single shaft, painted steel poles. Some locations the paint has started peeling, this should be treated to ensure rust does not occur in the future (Figure 4).

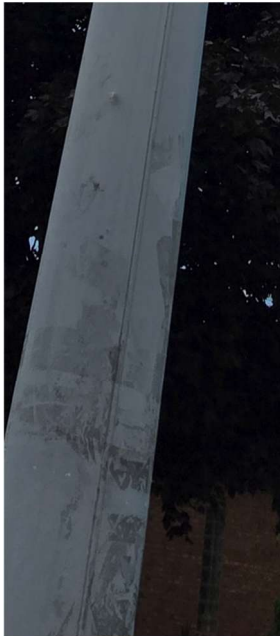
Figure 5: Painted Pole with Peeling Paint

- The poles at this intersection appear to be single shaft, painted steel poles. At some locations the paint has started peeling (Figure 5).

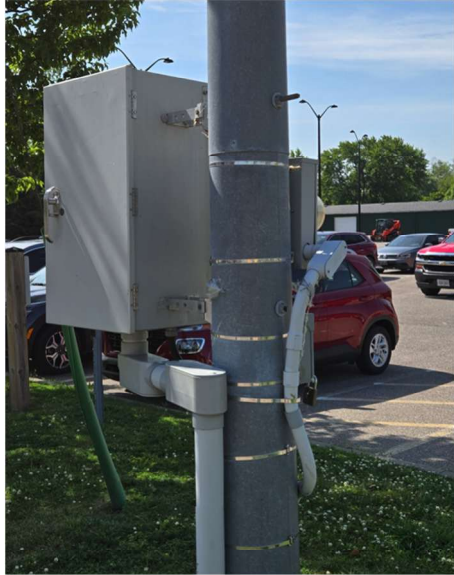
Figure 15: Damaged Conduit

- The pedestrian push button on the north side was not calling the accessible sound option.
- The pedestrian push button housings were showing signs of wear and peeling (Figure 17).
- The vehicle traffic signal housings were showing signs of wear and peeling.
- Conduit from the power supply cabinet has been taped together (Figure 15).

- Replace the pedestrian push buttons with similar models.
- Replace the vehicle traffic signal housings.
- Repair or replace the conduit at the power supply.

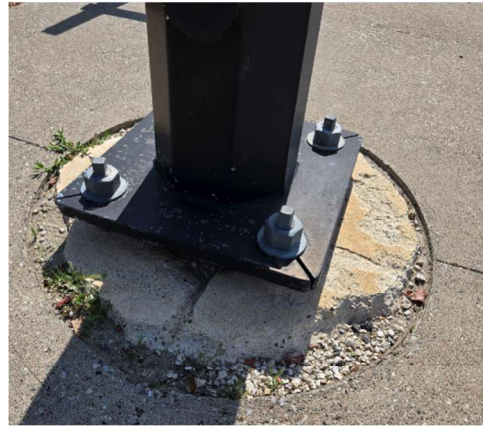
Figure 16: Concrete Spalling and Peeling Paint

- The pole bases are showing signs of spalling and will require monitoring (Figure 16).
- The bases of the decorative poles are showing signs of peeling and should be scraped and re-painted to extend the life of the poles (Figure 16).

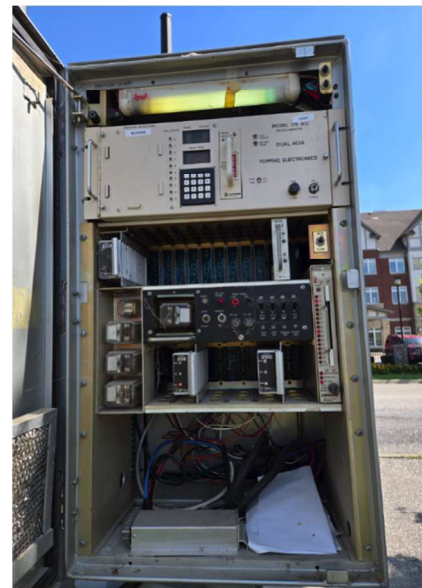
Figure 18: Pole Mounted Cabinet with 170 Controller

This intersection was installed in 2013. Since that time, maintenance has been carried out on an as-needed basis. In general, the equipment at this intersection is in good condition. The signal heads have newer polycarbonate housings. Luminaires were replaced between 2016 and 2018 with LED modules. Northbound signal heads were replaced in 2023. In general, the equipment at this intersection appears to have been well maintained and as a result, remains in fair condition. The pedestrian facilities do not meet AODA requirements. The traffic signal controller is in a pole mounted cabinet and is a 170 controller (Figure 18). Currently, the following items require attention:

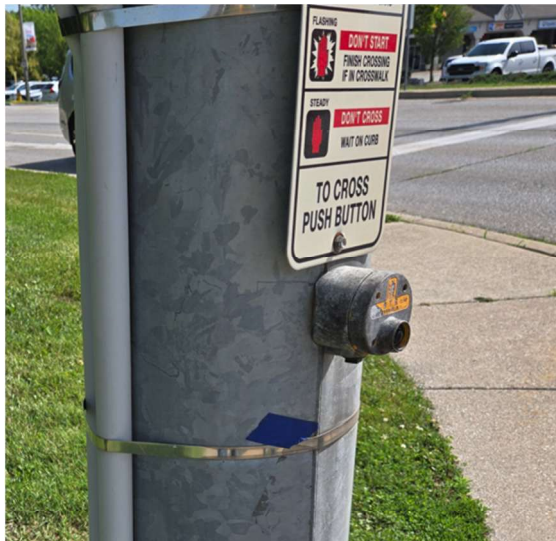
Figure 21: Pedestrian Push Button

- The pedestrian pads on the pedestrian push buttons are worn and the paint on the housing is peeling; however, they are still operating (Figure 21).
- The detector loops are still functioning; however, are past the end of their normal life.
- The power supply cabinet should be replaced as it is showing signs of corrosion (Figure 19), and the conduit has broken sections (Figure 18).
- The southbound secondary signal head is missing a backboard, located on the south leg median island.
- The southbound pedestrian signal head on the southeast corner is missing both visors and has twisted. (Figure 22).

- Replace the pedestrian push buttons with similar models.
- Replace the detector loops within the next 5 years.
- Replace the power supply cabinet and fix conduits.
- Replace backboards and visors, that are missing or damaged on signal heads.

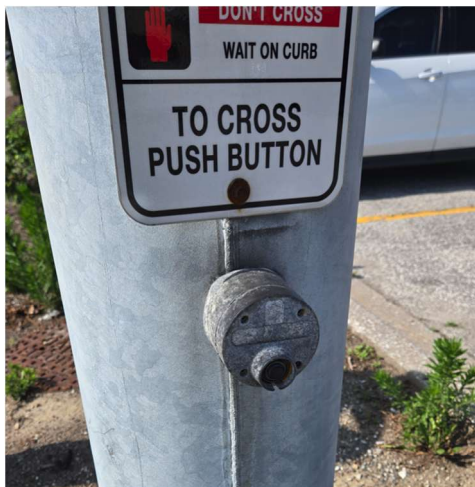
Figure 23: Pedestrian Push Button

- The pedestrian pads on the pedestrian push buttons are worn and the paint on the housing is peeling; however, they are still operating (Figure 23).
- The detector loops are still functioning; however, are past the end of their normal life.
- The power supply cabinet should be replaced as it is showing signs of corrosion (Figure 24) and the conduit has broken sections (Figure 25).

- Replace the pedestrian push buttons with similar models.
- Replace the detector loops within the next 4 years.
- Replace the power supply cabinet and fix conduits.

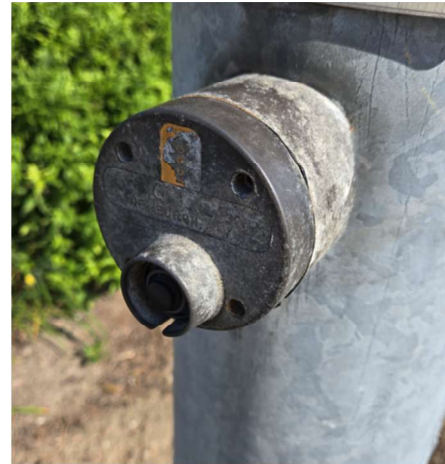
Figure 28: Pedestrian Push Button

- The pedestrian pads on the pedestrian push buttons are worn and the paint on the housing is peeling; however, they are still operating (Figure 28).
- The detector loops are still functioning; however, are past the end of their normal life.
- The northbound secondary signal head and the eastbound auxiliary signal head are missing backboards.

- Replace the pedestrian push buttons with similar models.
- Replace the detector loops within the next 5 years.
- Replace backboards that are missing or damaged on signal heads.

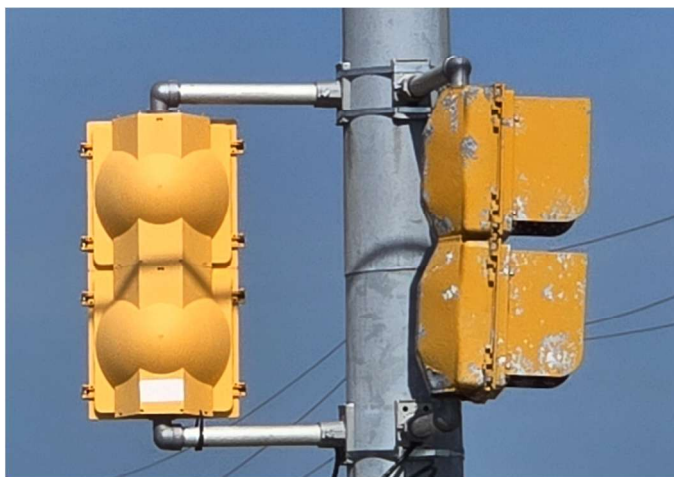
Figure 29: Pedestrian Signal Head Housing

- Several of the pedestrian signals remain in the original metal housings (Figure 29). While not a priority, the paint is peeling and therefore the visibility of the signal head to drivers and pedestrians is reduced. It is recommended to change these if the signal is not reconstructed within 5 years.

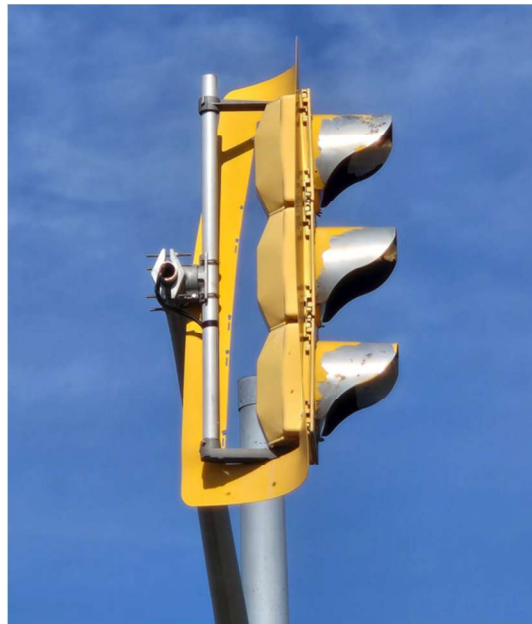
Figure 31: Traffic Signal Head Housing and Backboard

- The pedestrian pads on the pedestrian push buttons are worn and the paint on the housing is peeling; however, they are still operating.
- The detector loops are still functioning; however, are past the end of their normal life.
- There were some locations with damage to signal backboards (Figure 31).

- Replace the pedestrian push buttons with similar models.
- Replace the detector loops within the next 5 years.
- Replace backboards that are damaged on signal heads.

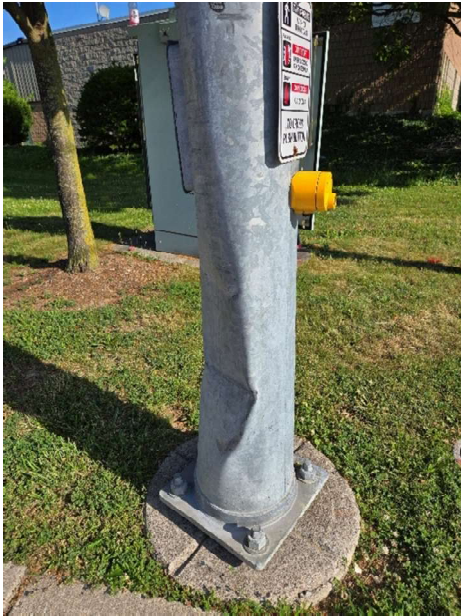
Figure 33: Traffic Signal Pole

- The pole on the northwest corner shows significant denting (Figure 33). While still standing and may have the ability to remain as such for several years. It is recommended to replace as this pole has several attachments that add strain to the pole structure.

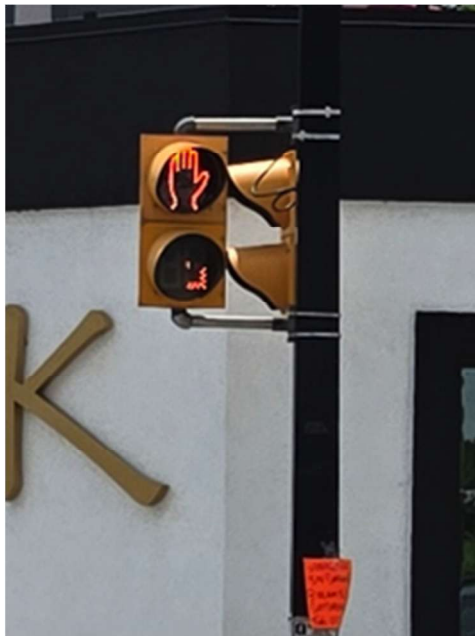
Figure 36: Pedestrian Signal Heads

Paint is peeling from the poles and mast arms; rust and corrosion is showing on most equipment (Figure 37). The decorative shoebox luminaires are no longer in working order. Traffic signal light modules were replaced between 1998 and 2000 with LED modules. The signal heads have newer polycarbonate housings. The signal infrastructure on the northwest corner is located on a joint use utility pole. The traffic signal cabinet is the original post mounted cabinet that is located inches from the curb and has been damaged by passing trucks on several occasions (Figure 38), however the controller has been replaced recently. The power supply cabinet is fully rusted and shows corrosion (Figure 36).

It is recommended that this signal system be reconstructed within the next year, including the replacement of poles, mast arms, traffic signal housings and LED modules, pedestrian signal housings and LED modules, UPS, new conduit and wiring as needed, upgrades to AODA pedestrian facilities, loop replacement, a new standard size concrete pad for the controller cabinet and handhole replacement as required. Some equipment may be near, but not at the end of its normal life, however it is recommend replacing all equipment at the same time to save on future maintenance costs. The traffic signal controller can be retained.
