Appendix E

Environmental Investigations

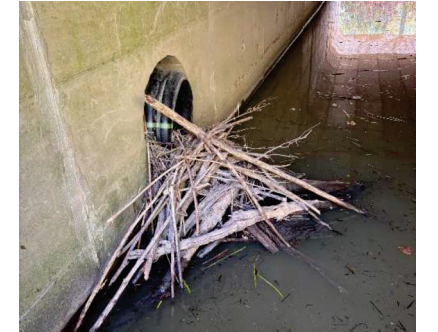
Photo 39: Habitat structure and Muskrat observed within concrete culvert at Crossing 7.

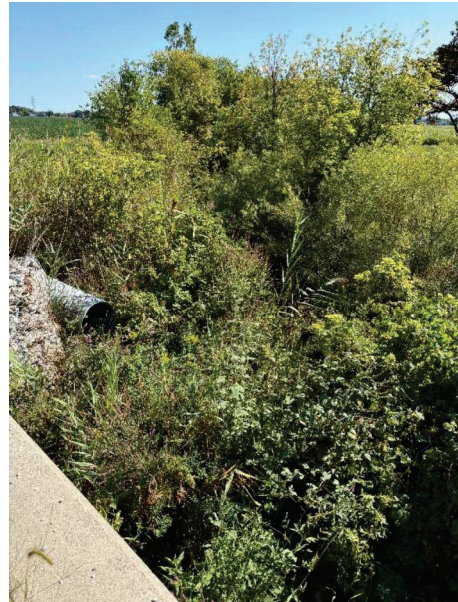
Photo 40: Facing south at Crossing 8, from south side of County Road 46.

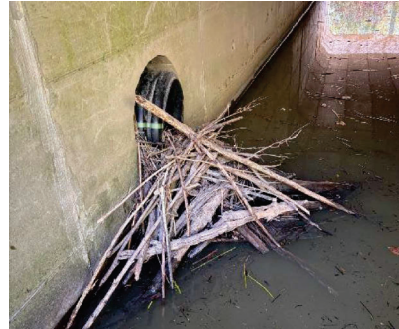
Photo 39: Habitat structure and Muskrat observed within concrete culvert at Crossing 7.

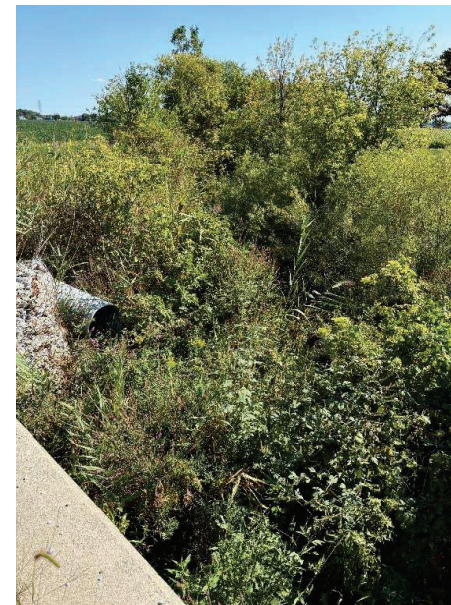
Photo 40: Facing south at Crossing 8, from south side of County Road 46.
