TOWN OF TECUMSEH

Groundwater and Methane Investigation

Tecumseh Hamlet Secondary Planning Area

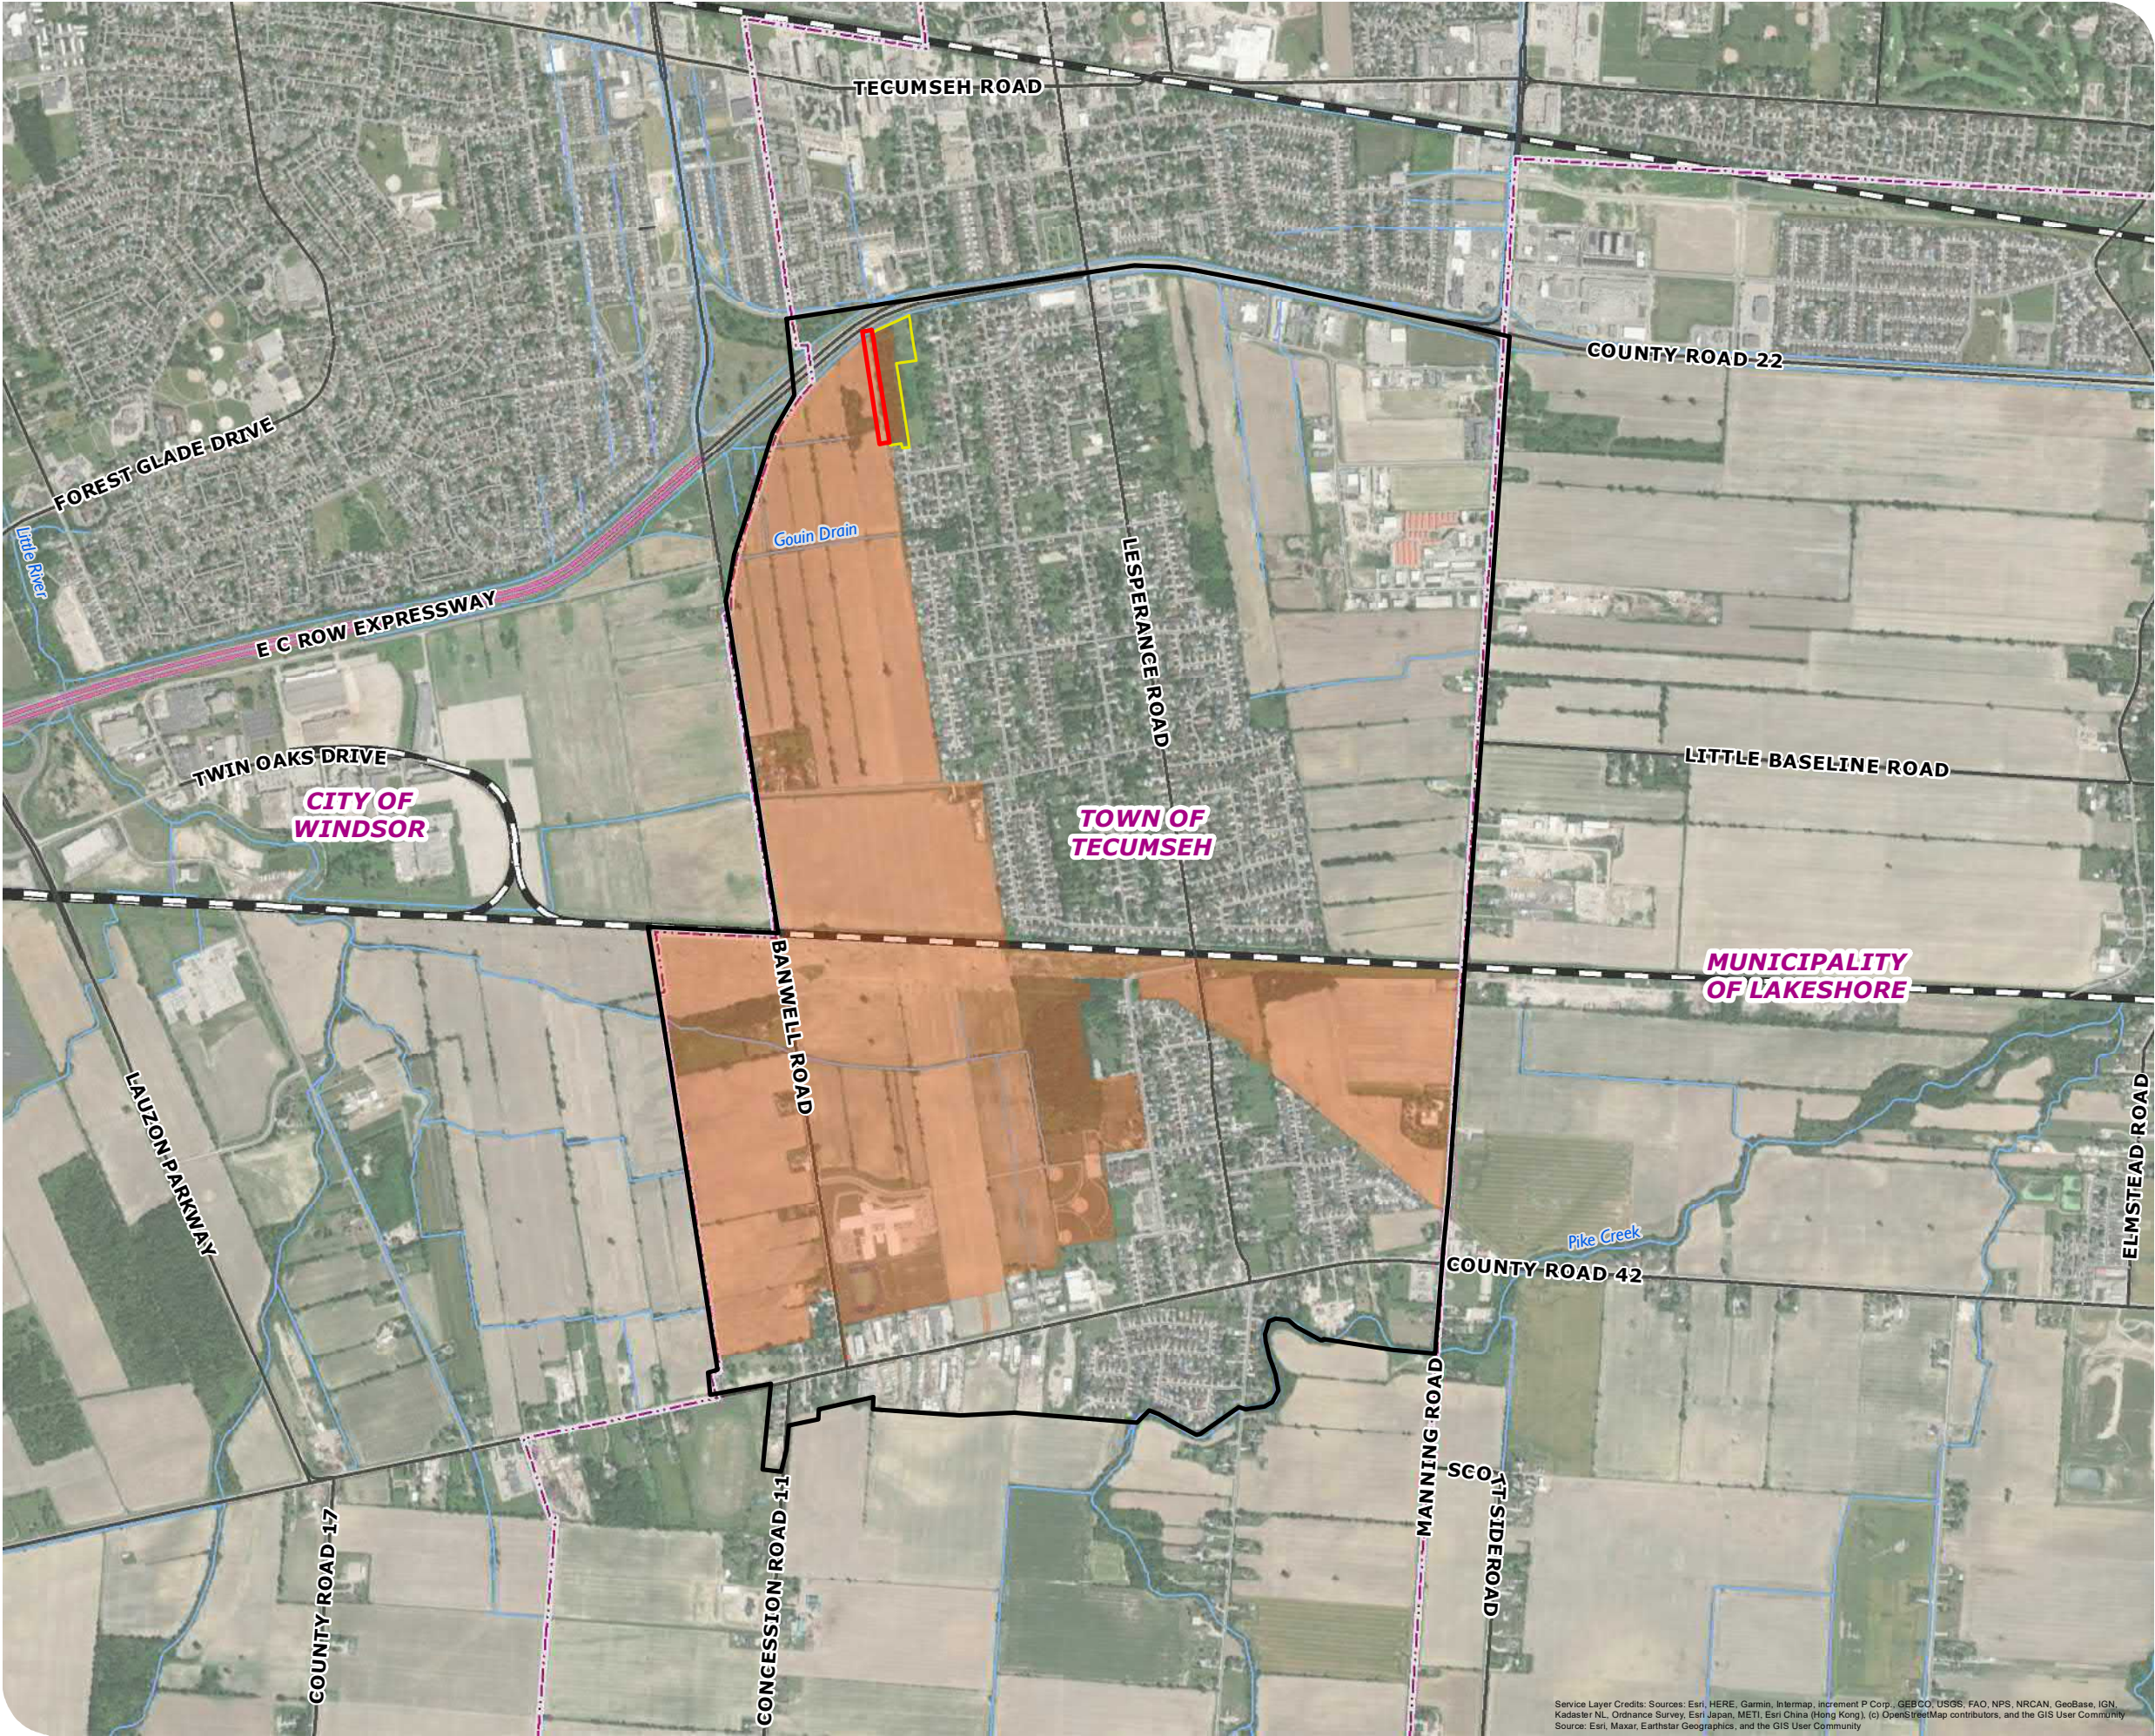
FIGURE 1

The Hamlet SPA is located between the EC Row Expressway and Country Road 42 in the areas of Lesperance Road and Banwell Road in Tecumseh, Ontario. The focus of this investigation was lands in the northern area of the Hamlet SPA, located adjacent west of the former MTO waste disposal site (ARN: 374457000046900). The location of the investigation, Hamlet SPA and former MTO waste disposal site are presented on Figure 1.

Dillon Consulting Limited (Dillon) was retained by the Town of Tecumseh (Town) (the “Client”) to conduct a groundwater and methane investigation for lands within the Tecumseh Hamlet Secondary Planning Area (Hamlet SPA) which are adjacent to a former Ministry of Transportation, Ontario (MTO) waste disposal site. The locations of the investigation, Tecumseh Hamlet SPA and MTO waste disposal site are shown on Figure 1.

Based on the review of the Hamlet SPA, it was identified that a former MTO waste disposal site is located within the Hamlet SPA, south of the EC Row Expressway and west of Shawnee Street in Tecumseh, Ontario (ARN: 374457000046900, PIN: 752420205) (Figure 1).

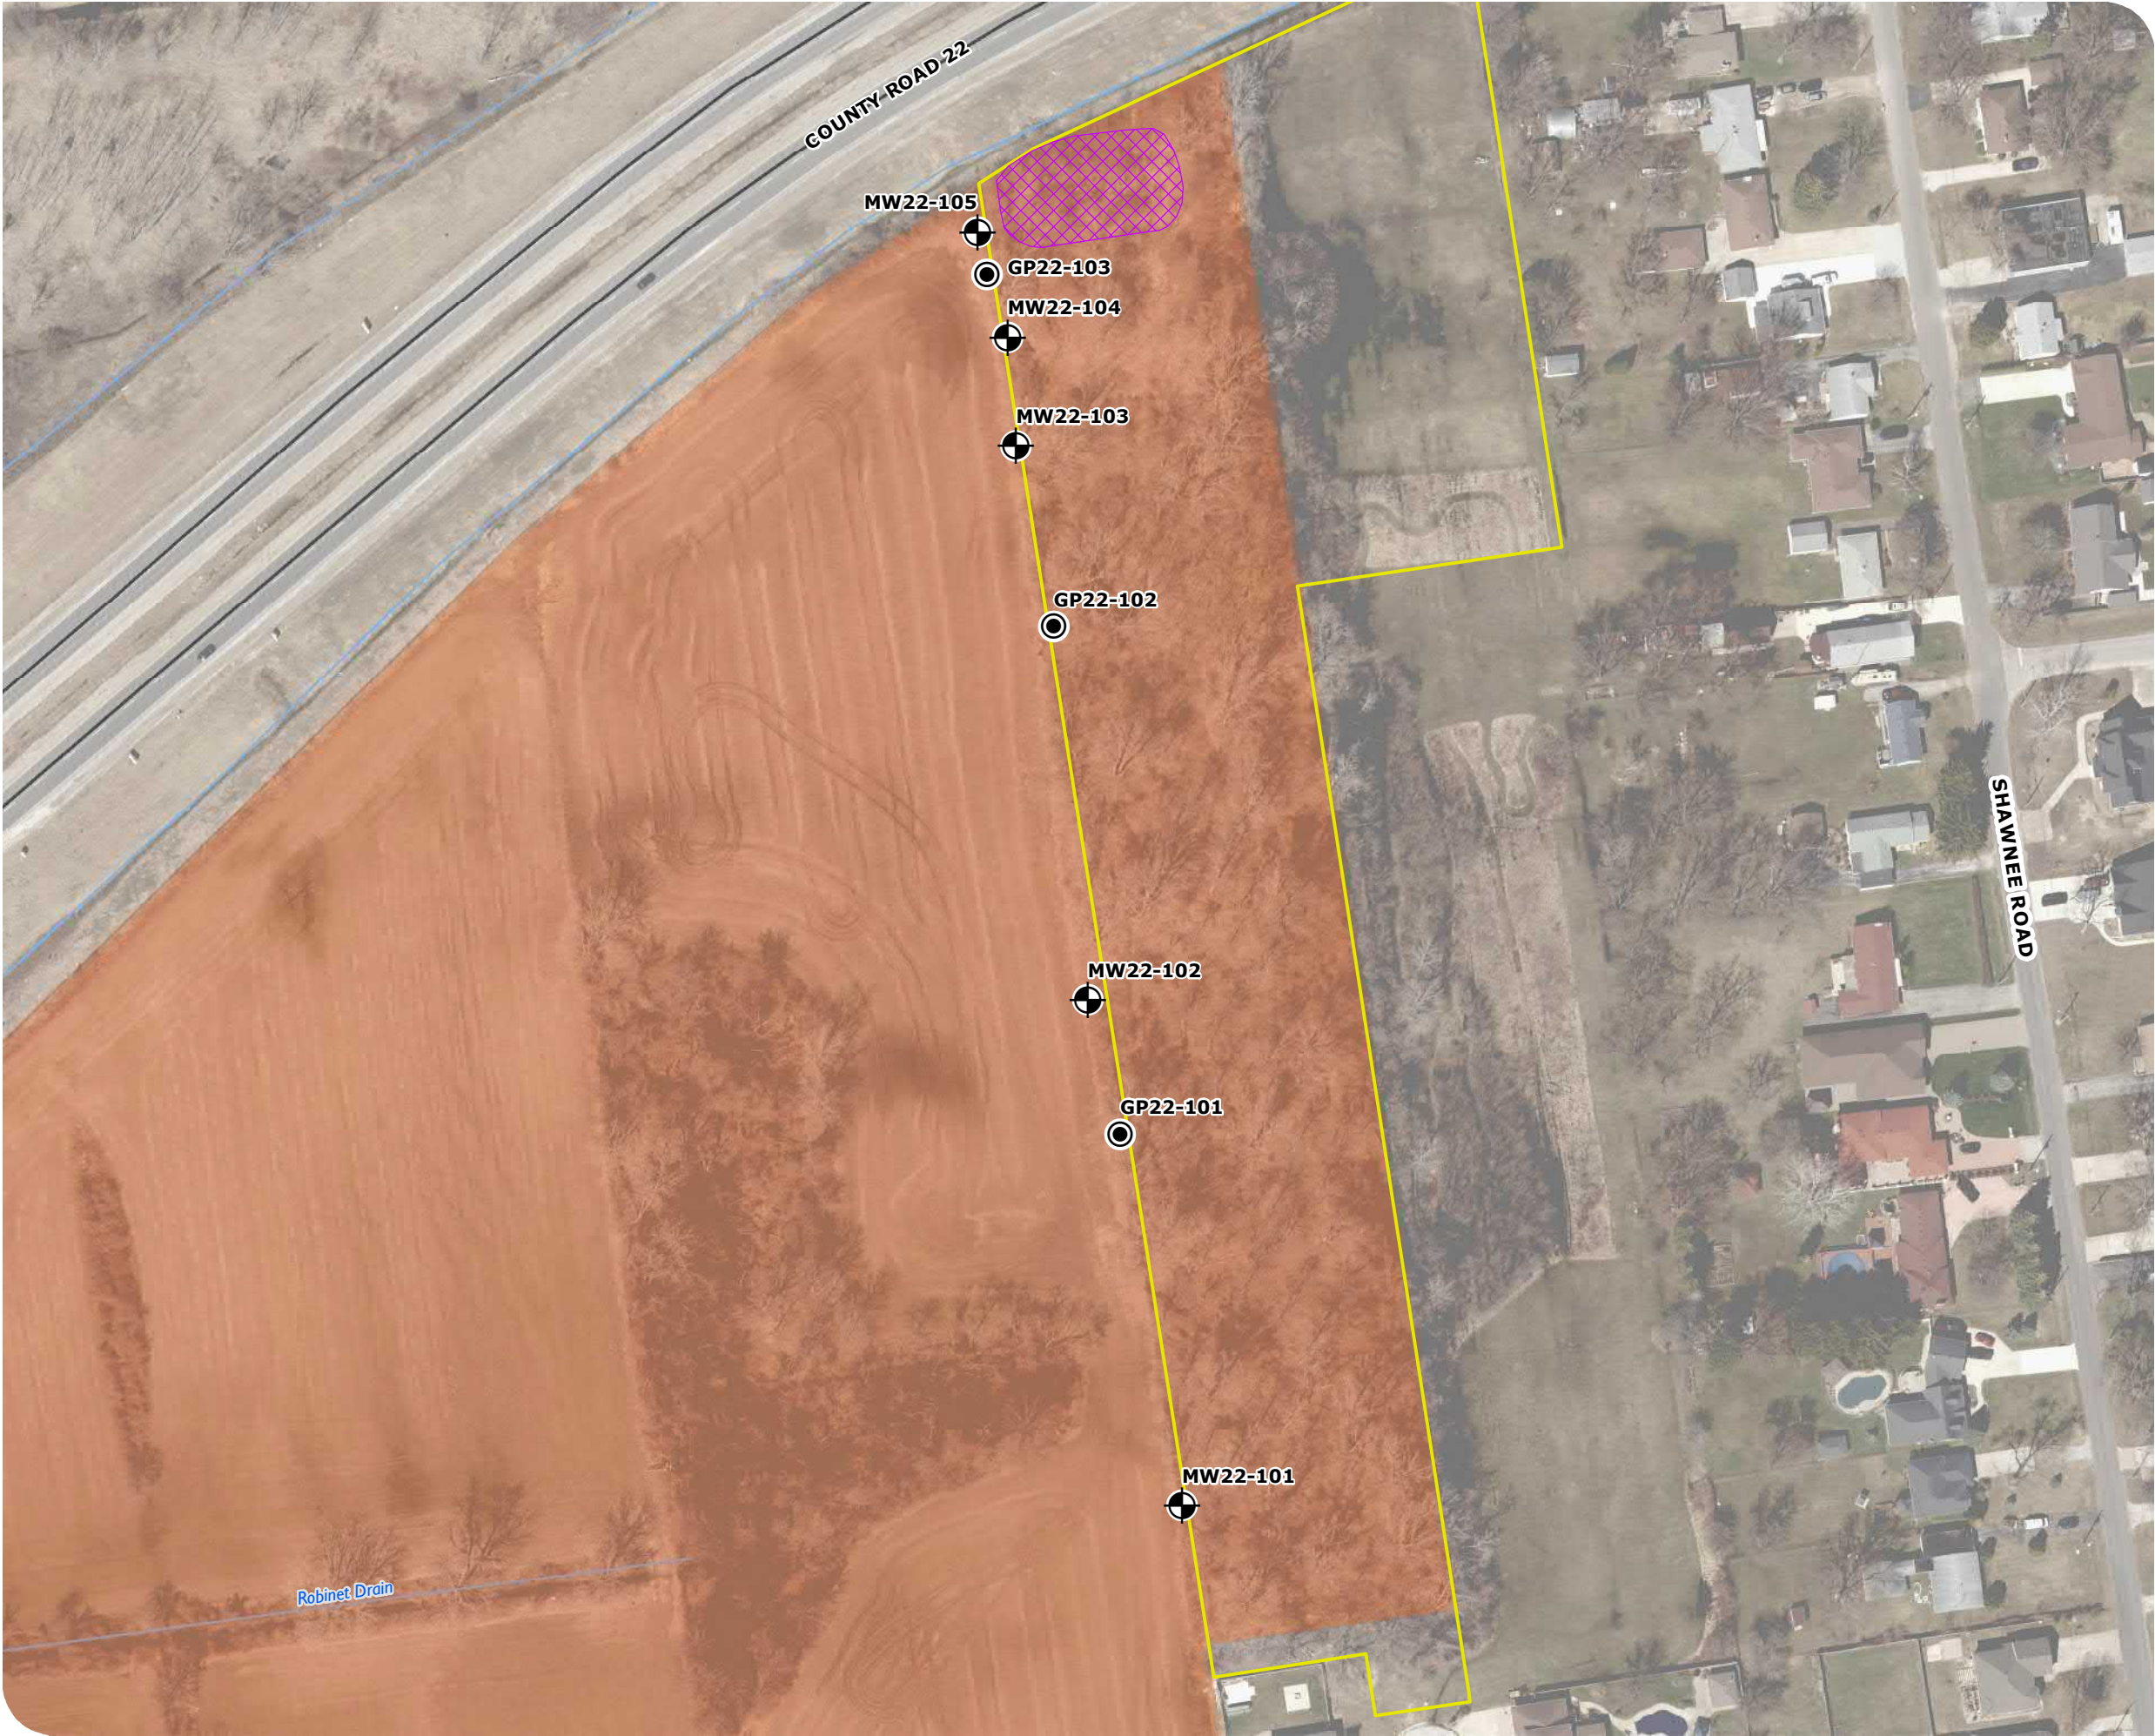
The report titled *Geotechnical Investigation Hwy #2 Bypass/Shawnee Road Subdivision, Sandwich South Township, Essex County, Gartner Lee Associates Limited, 1979* indicated that the former MTO disposal site includes a former borrow pit which was filled with garbage, foundry sands and fill to a depth of up to approximately 4 m. Refuse was found in the northern area of the waste disposal site, with foundry sands deposited overtop of the refuse and the remainder of the waste disposal site, and fill was used to cap the area. The report also indicated methane gas was detected in qualities greater than the lower explosive limit (5% by volume) in areas of refuse. The approximate area of the refuse as documented in the previous report is displayed on Figure 2.

Dillon retained Landshark Group to drill the boreholes and install the gas probes and groundwater monitoring wells. The boreholes were drilled on September 8, 2022, using a track-mounted direct push drilling rig (Geoprobe 7822DT). Soil cores were collected using 38 mm outside diameter, 1.5 m long, plastic sample sleeves. No drilling fluids or lubricants were used. Sample sleeves generated during the investigation were taken off-site by the driller for disposal. The gas probe and monitoring well locations are displayed on Figure 2.

Gas probes were installed at three of the borehole locations to monitor for methane gas. The gas probe locations are displayed on Figure 2.

Monitoring wells were installed at five of the borehole locations to assess groundwater quality and flow direction. The monitoring well locations are displayed on Figure 2.

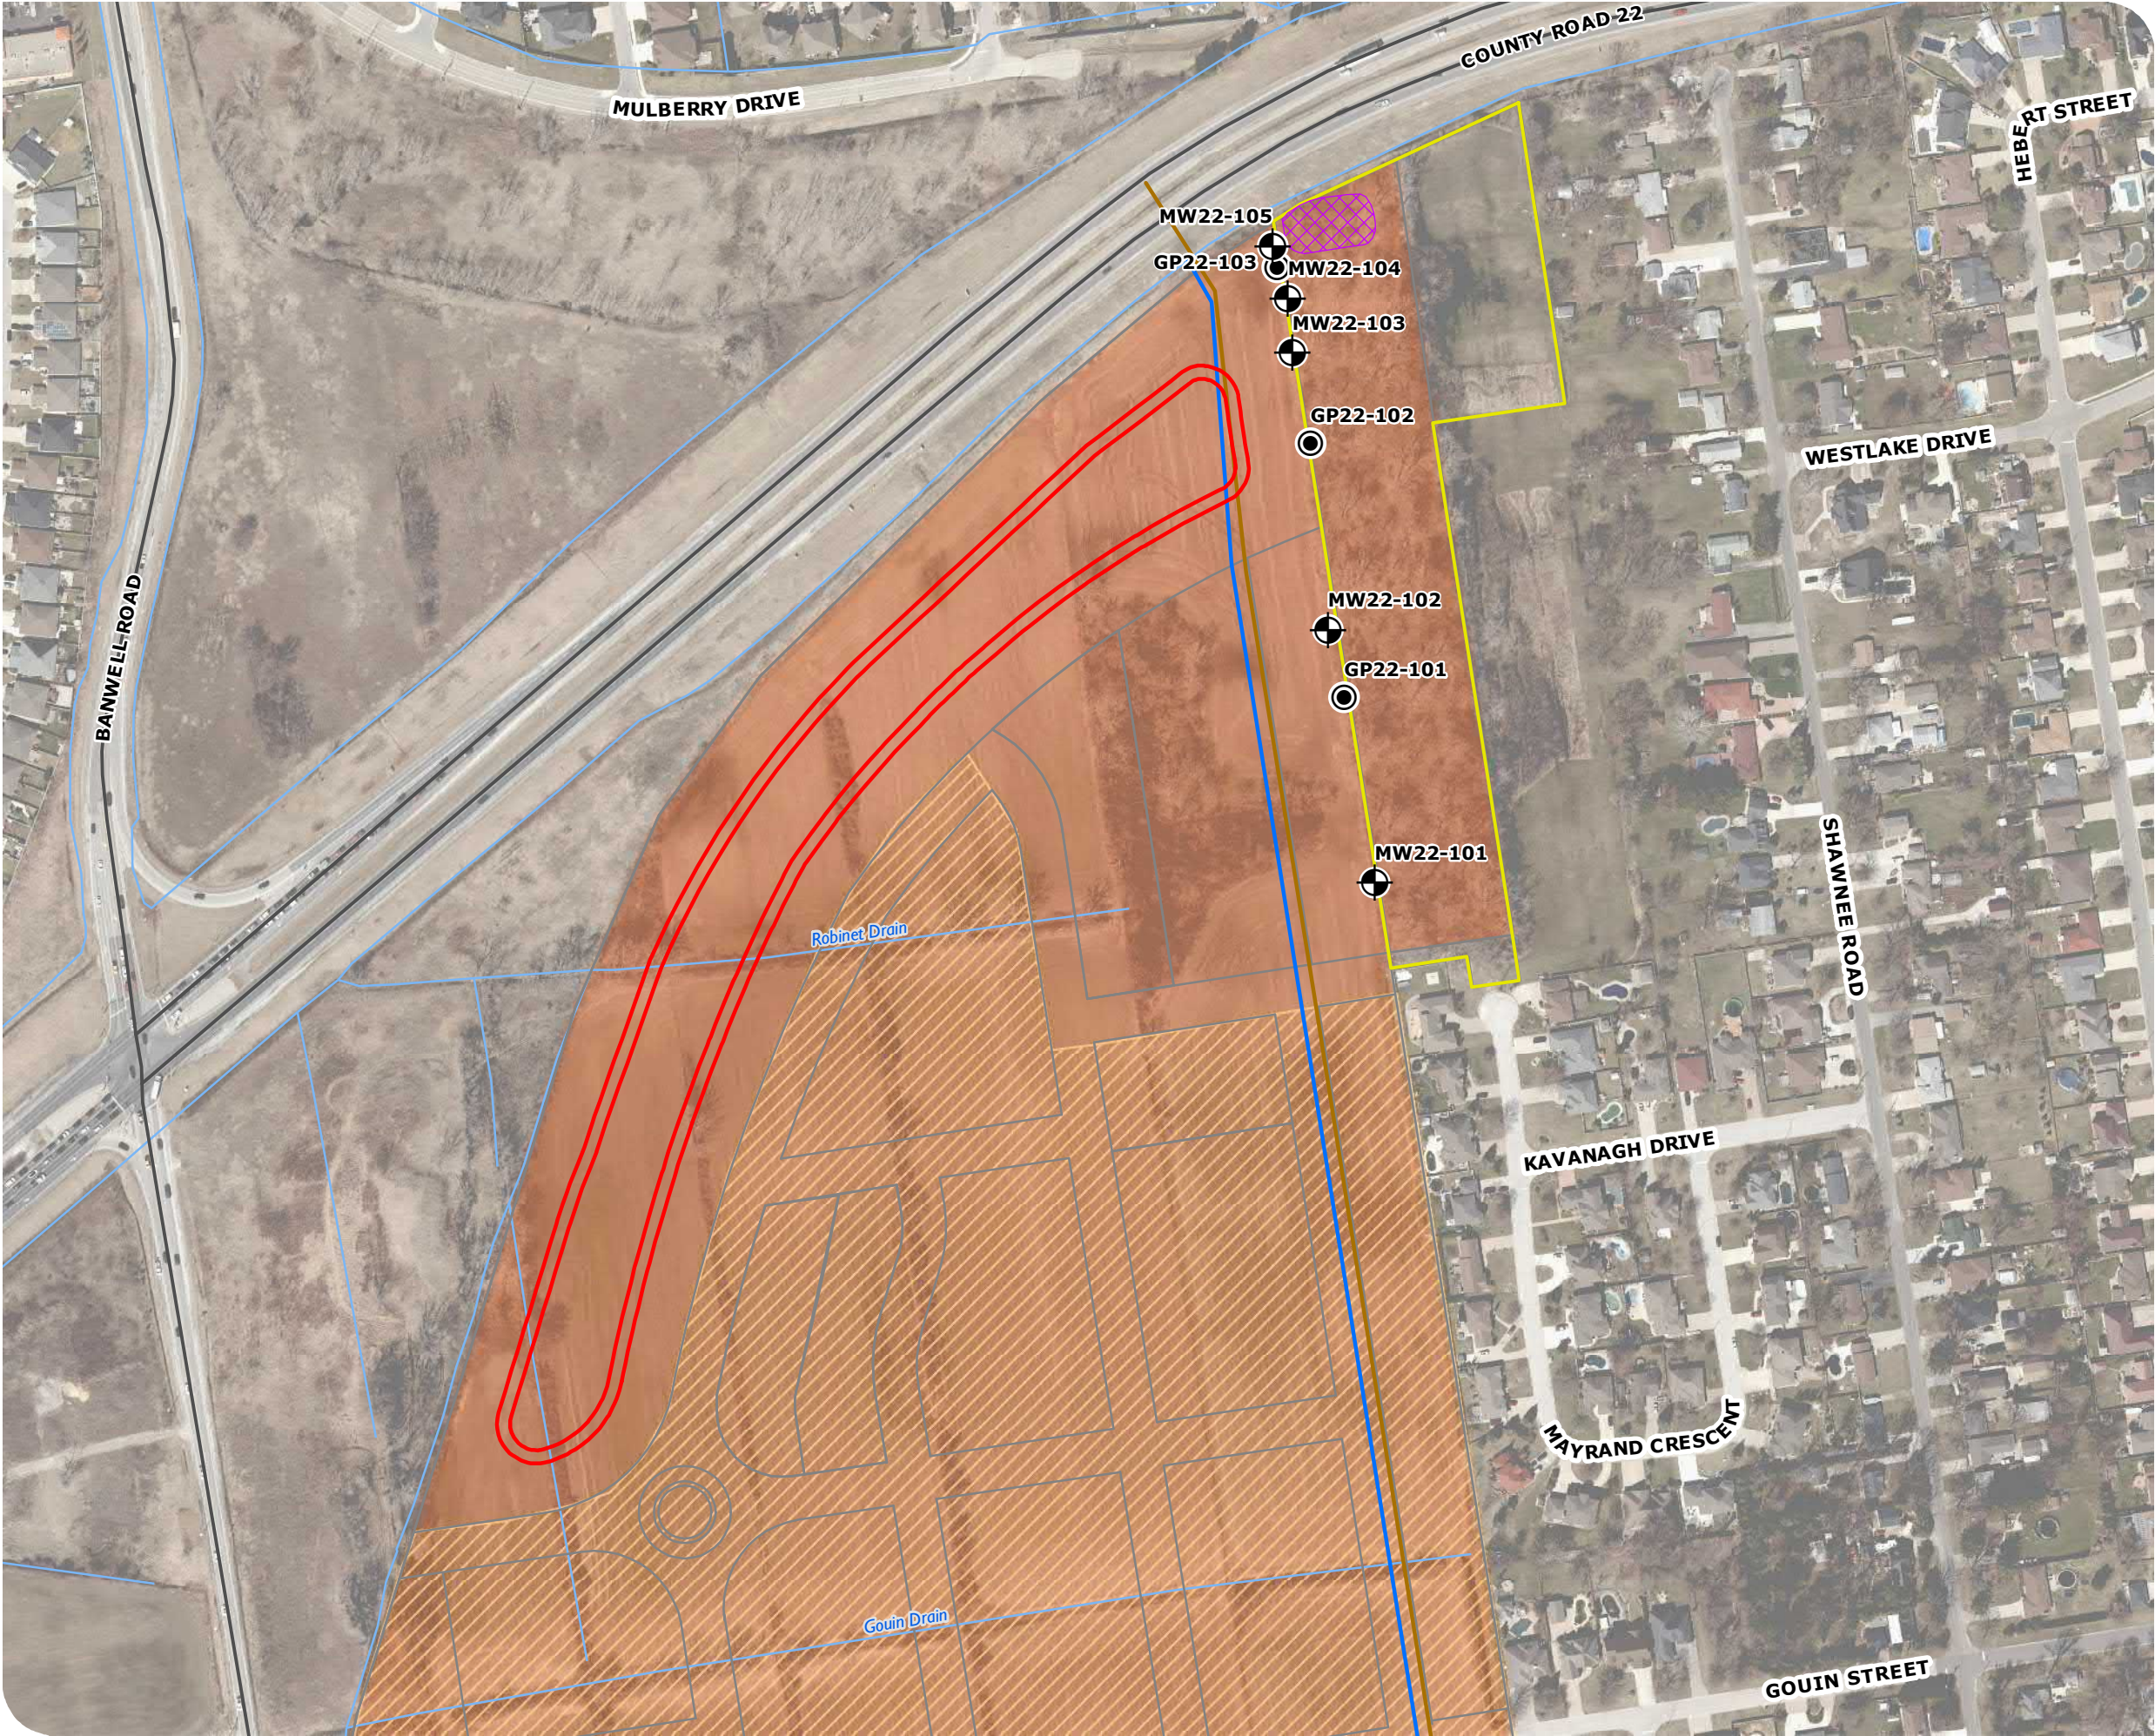
A storm water pond is proposed to be located in the northern area of the Hamlet SPA, adjacent west of the former MTO waste disposal site (see Figure 3). A storm water pond is considered a compatible land use. It is recommended that the storm water pond have a 10 m set back from the former MTO waste disposal site. As a best practice it is also recommended that an engineered liner be installed in parts of the storm water pond within 30 m of the former MTO waste disposal site to prevent groundwater from infiltrating the storm water pond.

A trunk sanitary sewer and water main is proposed to traverse the Hamlet SPA north to south adjacent west of the former MTO waste disposal site (see Figure 3). Utilities are considered a compatible land use. It is recommended that the trunk sanitary sewer and watermain and other proposed buried utilities, have a 10 m set back from the former MTO waste disposal site. As a best practice it is recommended that clay cut offs are installed in utility trenches within 30 m of the former MTO waste disposal site to prevent groundwater from infiltrating the utility trenches and acting as a preferential pathway.

Residential development is proposed further west and southwest of the former MTO waste disposal site (see Figure 3). Residences are a sensitive land use, as such a 30 m setback from the former MTO waste disposal site is recommended.

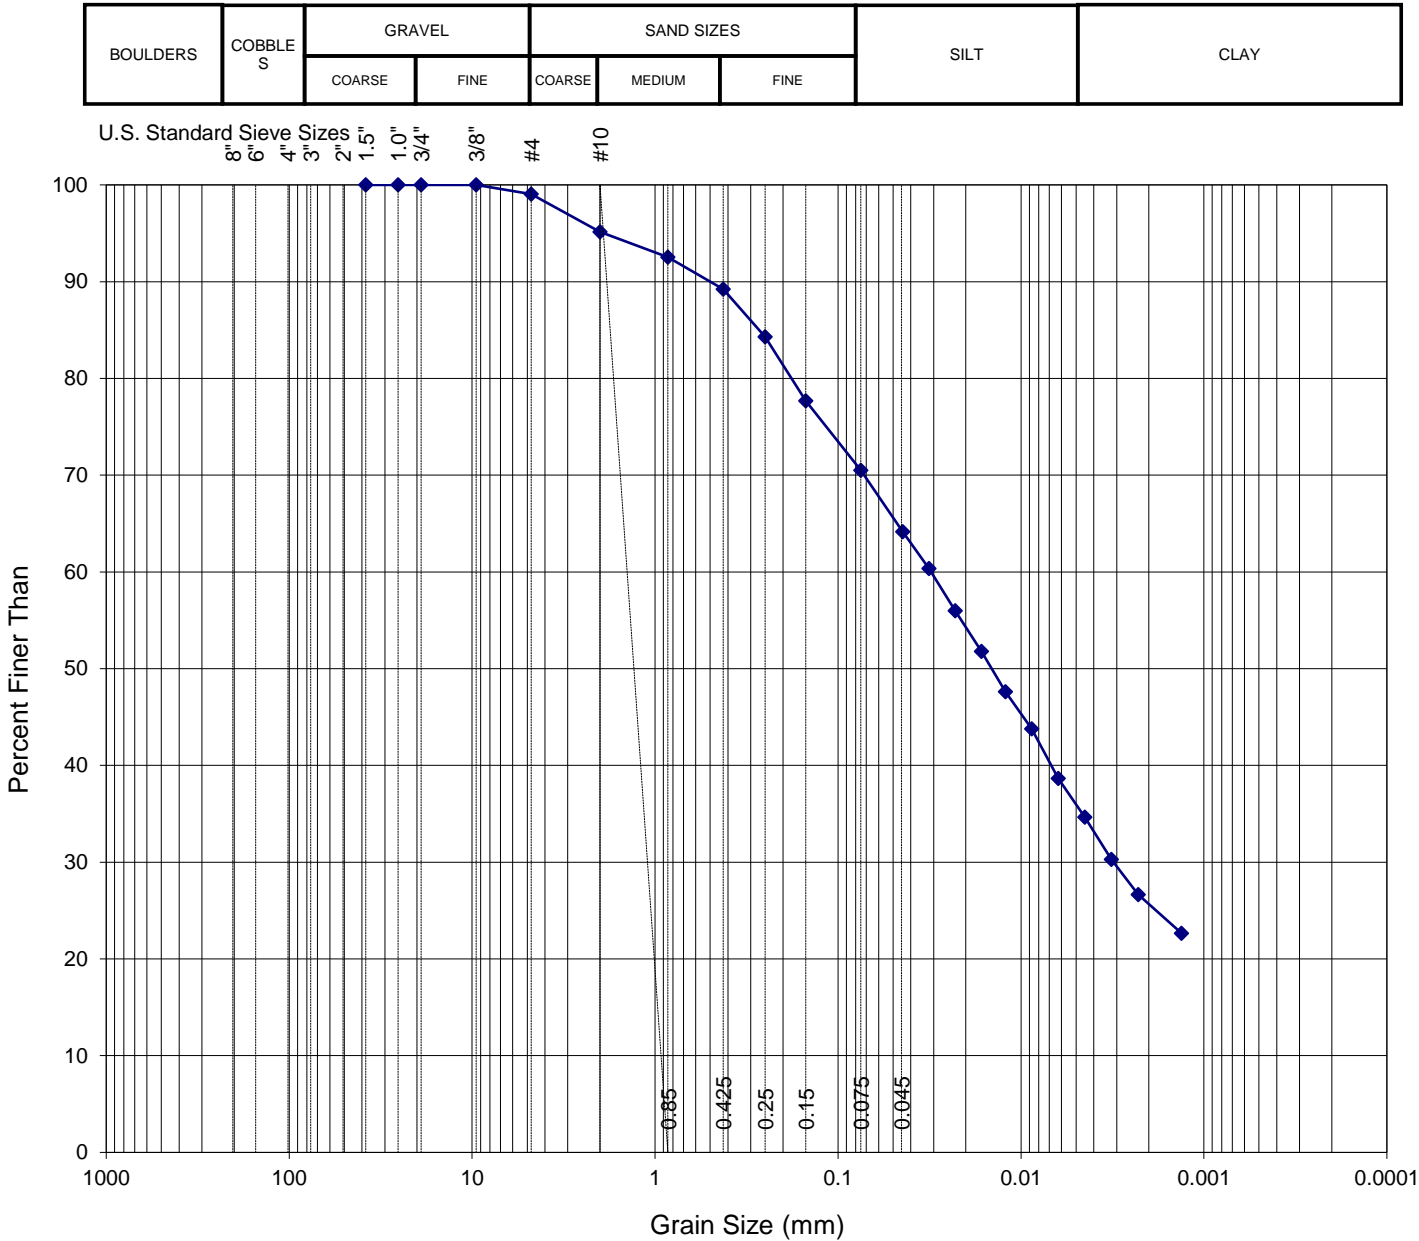
PARTICLE SIZE DISTRIBUTION CURVE

METHOD DESCRIPTION		SUMMARY OF RESULTS		
Method Reference: ASTM D6913 & D7928		GRAIN SIZE	WT %	DIA. RANGE (mm)
Dispersion method: Mechanical		% GRAVEL :	<1	> 4.75
Dispersion period: 1 minute		% COARSE SAND :	3.91	2.0 - 4.75
		% MEDIUM SAND :	5.92	0.425 - 2.0
		% FINE SAND :	18.73	0.075 - 0.425
DESCRIPTION OF SAND AND GRAVEL PARTICLES		% SILT :	34.52	0.075 - 0.005
Shape: Angular		% CLAY :	35.98	< 0.005
Hardness: Hard

Based on the documented properties of silty clay soil, the results of the grain size analysis, and supported by the slow rate of recovery observed in groundwater monitoring wells, the hydraulic conductivity of the native silty clay in the investigation area was estimated to be between 1×10^{-6} to 1×10^{-9} cm/s.

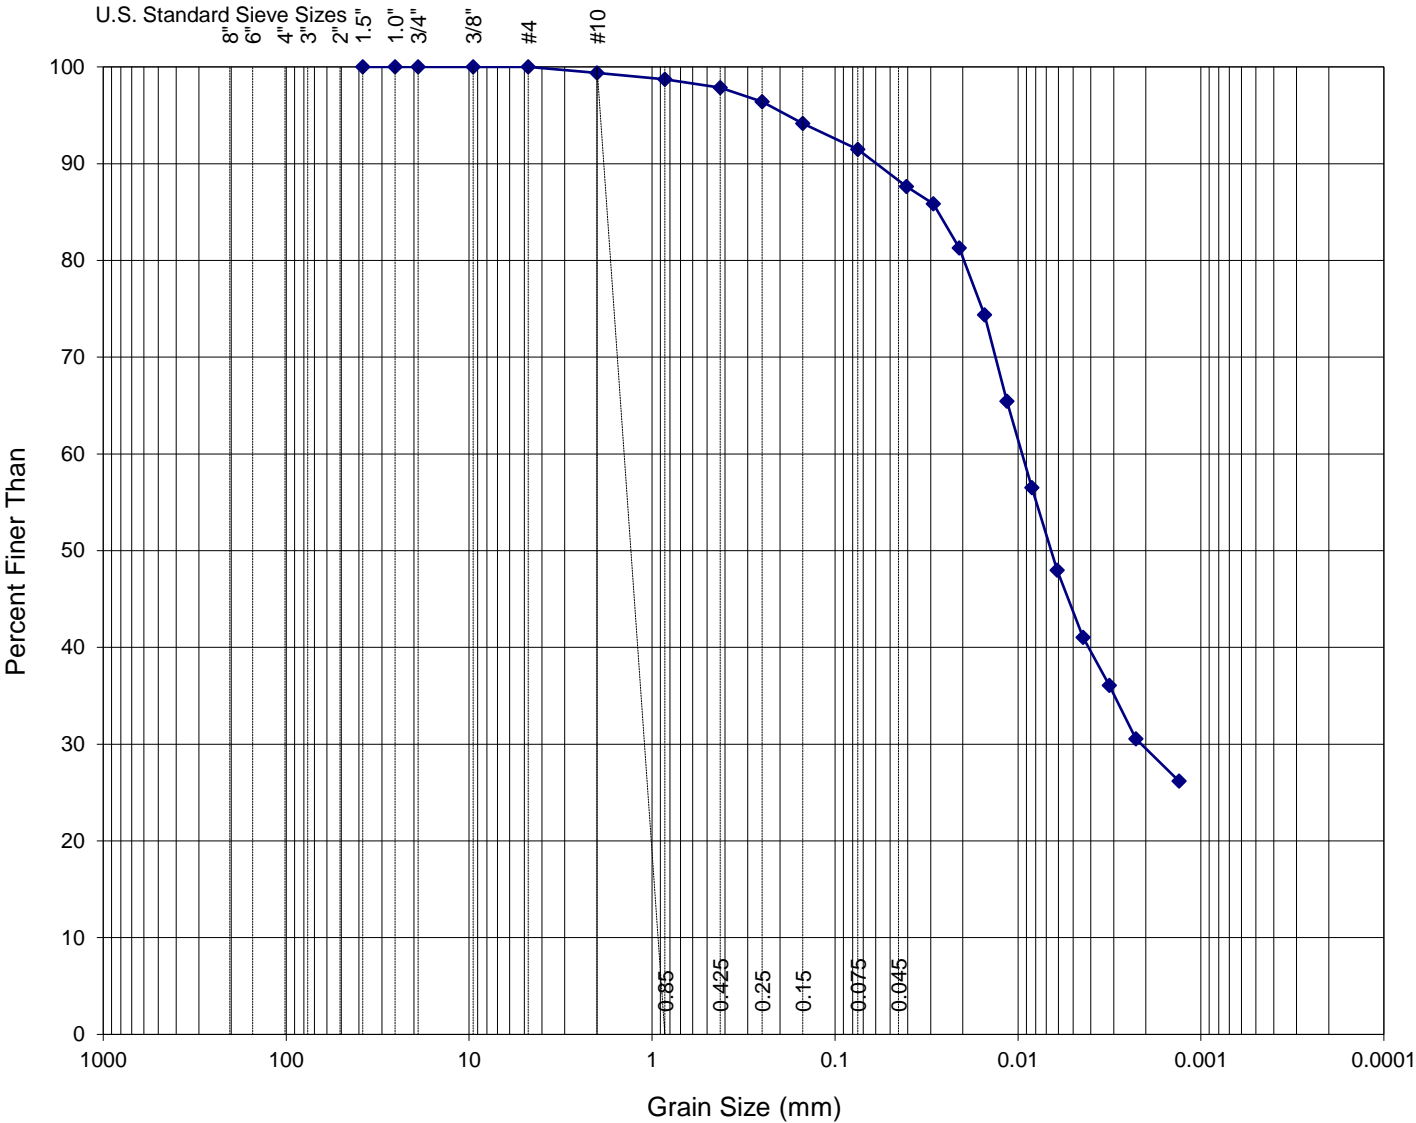
BOULDERS	COBBLES	GRAVEL		SAND SIZES			SILT	CLAY
		COARSE	FINE	COARSE	MEDIUM	FINE

METHOD DESCRIPTION		SUMMARY OF RESULTS		
Method Reference: ASTM D6913 & D7928		GRAIN SIZE	WT %	DIA. RANGE (mm)
Dispersion method: Mechanical		% GRAVEL :	<1	> 4.75
Dispersion period: 1 minute		% COARSE SAND :	<1	2.0 - 4.75
		% MEDIUM SAND :	1.54	0.425 - 2.0
		% FINE SAND :	6.37	0.075 - 0.425
DESCRIPTION OF SAND AND GRAVEL PARTICLES		% SILT :	47.74	0.075 - 0.005
Shape: Angular		% CLAY :	43.74	< 0.005
Hardness: Hard

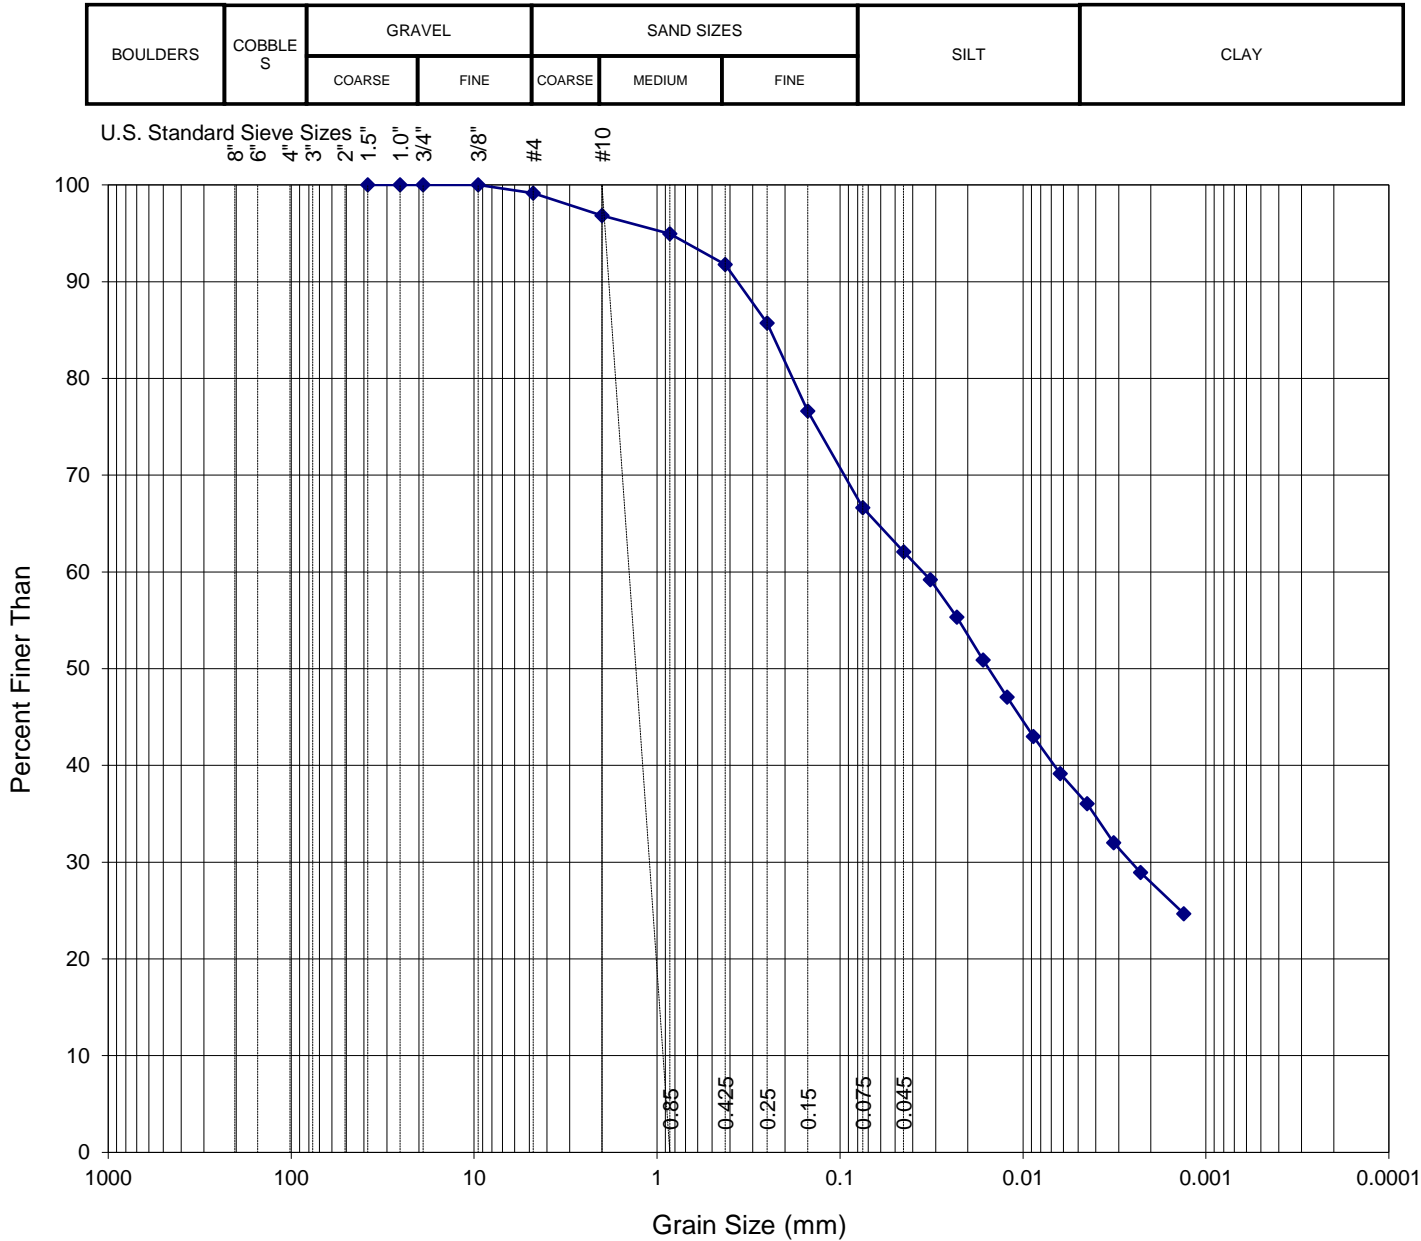
Client Name: SK2205827003
Project Number:
Client Sample ID Grain Size 3
Lab Sample ID SK2205827003
Date Sample Received 00-Jan-00
Test Completion Date: 25-Oct-22
Analyst: SIH

METHOD DESCRIPTION		SUMMARY OF RESULTS		
Method Reference: ASTM D6913 & D7928		GRAIN SIZE	WT %	DIA. RANGE (mm)
Dispersion method: Mechanical		% GRAVEL :	<1	> 4.75
Dispersion period: 1 minute		% COARSE SAND :	2.30	2.0 - 4.75
		% MEDIUM SAND :	5.07	0.425 - 2.0
		% FINE SAND :	25.14	0.075 - 0.425
DESCRIPTION OF SAND AND GRAVEL PARTICLES		% SILT :	29.53	0.075 - 0.005
Shape: Angular		% CLAY :	37.09	< 0.005
Hardness: Hard

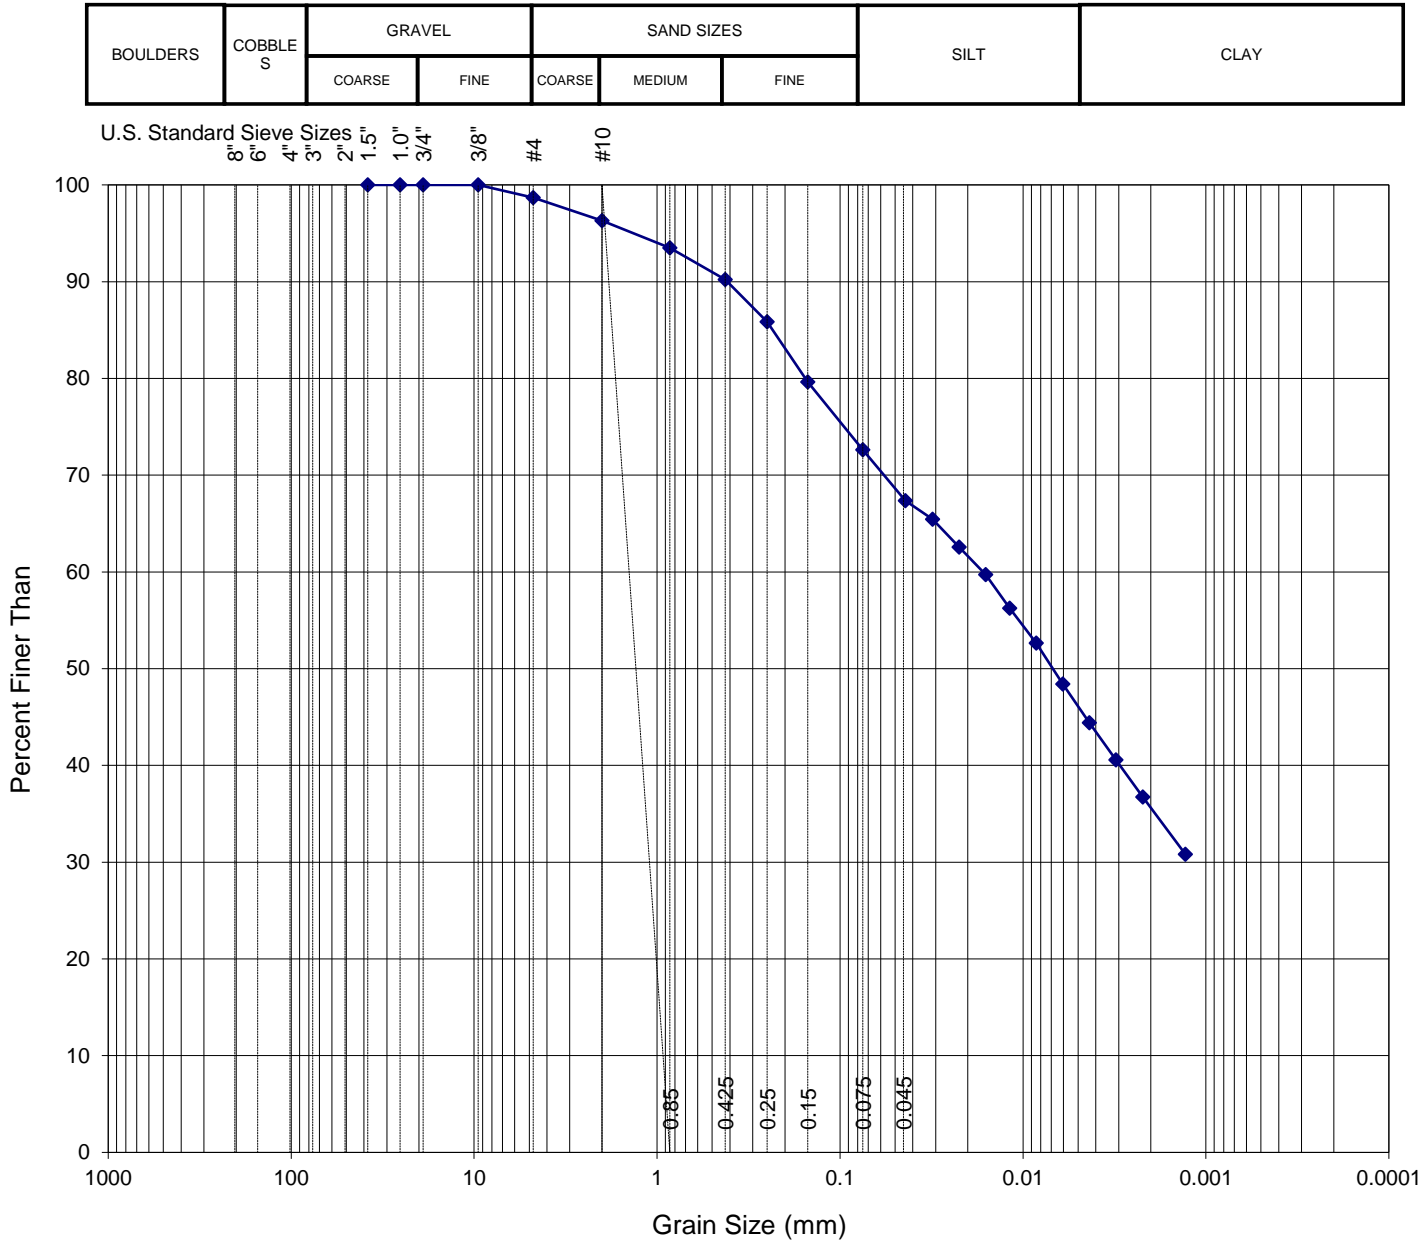
Client Name: SK2205827004
Project Number:
Client Sample ID Grain Size 9
Lab Sample ID SK2205827004
Date Sample Received 00-Jan-00
Test Completion Date: 25-Oct-22
Analyst: SIH

METHOD DESCRIPTION		SUMMARY OF RESULTS		
Method Reference: ASTM D6913 & D7928		GRAIN SIZE	WT %	DIA. RANGE (mm)
Dispersion method: Mechanical		% GRAVEL :	1.33	> 4.75
Dispersion period: 1 minute		% COARSE SAND :	2.38	2.0 - 4.75
		% MEDIUM SAND :	6.07	0.425 - 2.0
		% FINE SAND :	17.59	0.075 - 0.425
DESCRIPTION OF SAND AND GRAVEL PARTICLES		% SILT :	26.52	0.075 - 0.005
Shape: Angular		% CLAY :	46.11	< 0.005
Hardness: Hard
