TECHNICAL REPORT

2025 Traffic Signal Assessment Updates

Town of Tecumseh

PBX Engineering Ltd.

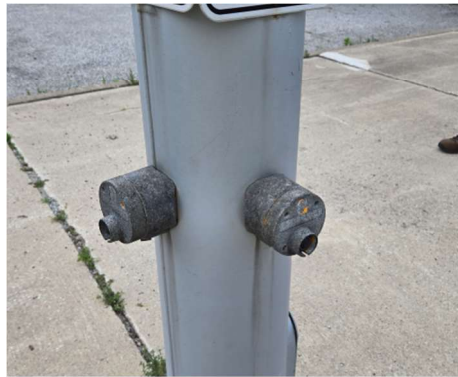
Figure 6: Pedestrian Push Buttons

- The pedestrian signal heads require the LED modules to be replaced due to several LEDs being burnt out.
- The signal heads require the LED modules to be replaced as standard maintenance practice.
- The pedestrian pads on the pedestrian push buttons are worn and the paint on the housing is peeling; however, they are still operating (Figure 6).
- The detector loops are still functioning; however, are past the end of their normal life.

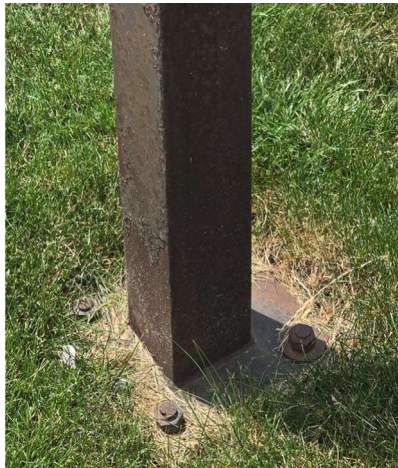
Figure 8: Painted Pole with Peeling Paint

This intersection was installed in approximately 1981. In general, the equipment at this intersection is past the end of normal life and in poor condition. Paint is peeling from the poles and mast arms; rust and corrosion is showing on most equipment (Figure 8 & 9). The decorative shoebox luminaires are no longer in working order. Traffic signal light modules were replaced between 1998 and 2000 with LED modules. The signal heads have newer polycarbonate housings. The west median signal head was replaced in 2018. The pedestrian facilities do not meet AODA requirements. The traffic signal controller was replaced recently, and a UPS was added to the cabinet. The concrete pad for this controller is too small and does not meet OPS Standards.

It is recommended that this signal system be reconstructed within the next year, including the replacement of poles, mast arms, traffic signal housings and LED modules, pedestrian signal housings and LED modules, new conduit and wiring as needed, upgrades to AODA pedestrian facilities, loop replacement and handhole replacement as required. The traffic signal controller, UPS and cabinet can be retained; however, the UPS batteries should be replaced.

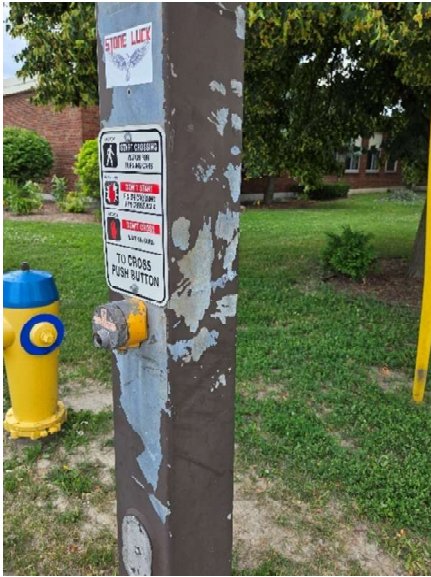
Figure 10: Peeling Paint and Push Button

This intersection was installed in approximately 1981. In general, the equipment at this intersection is past the end of normal life and in poor condition. Paint is peeling from the poles and mast arms; rust and corrosion is showing on most equipment (Figure 10). The decorative shoebox luminaires are no longer in working order. The southwest pole and mast arm were replaced in 2016 with a wood pole, creating an overhead span across the west leg of the intersection (Figure 12). The overhead span is connected on the northwest corner to the decorative pole; there is no documented structural review to confirm this configuration is sustainable.

It is recommended that this signal system be reconstructed within the next year, including the replacement of poles, mast arms, traffic signal housings and LED modules, pedestrian signal housings and LED modules, new conduit and wiring as needed, upgrades to AODA pedestrian facilities and handhole replacement as required. The traffic signal controller, UPS and cabinet can be retained; however, the UPS batteries should be replaced.

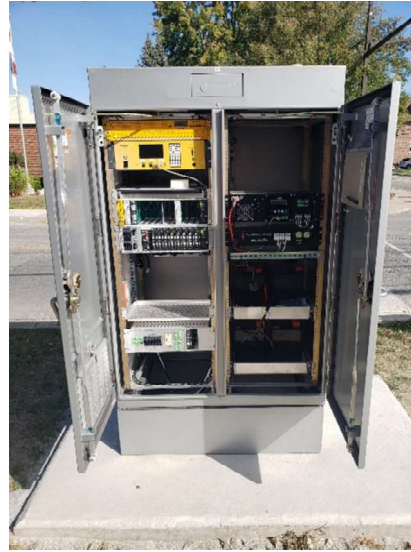
Figure 11: New Cabinet and Controller

Traffic signal light modules were replaced between 1998 and 2000 with LED modules. The signal heads have newer polycarbonate housings. The pedestrian facilities do not meet AODA requirements. The cabinet and controller were recently replaced, with a UPS included. Loops were recently replaced as well.

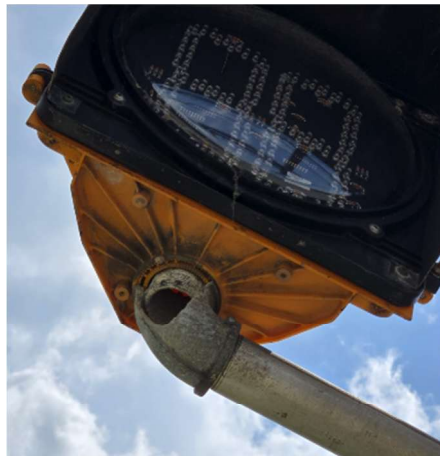
Figure 13: Broken Arm

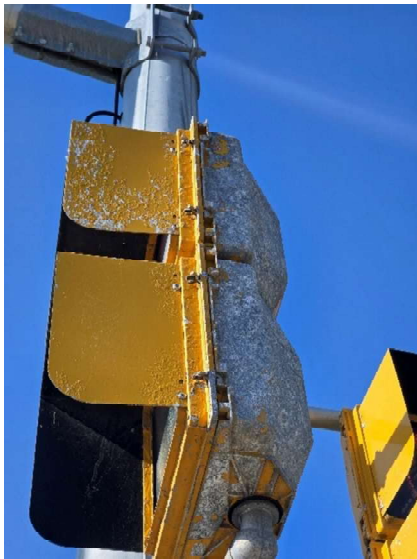
Figure 30: Pedestrian Signal Head Housing

- This location does not currently have a UPS. While this location is not considered high priority due to traffic volumes on the side street, if the Town’s standard is to include a UPS on all traffic signals, one could be added.
- Several of the pedestrian signals remain in the original metal housings (Figure 30). While not a priority, the paint is peeling and therefore the visibility of the signal head to drivers and pedestrians is reduced. It is recommended to change these if the signal is not reconstructed within 5 years.

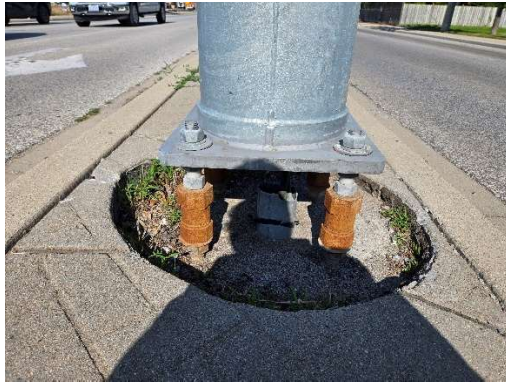
Figure 32: Traffic Pole Base and Anchor Bolts

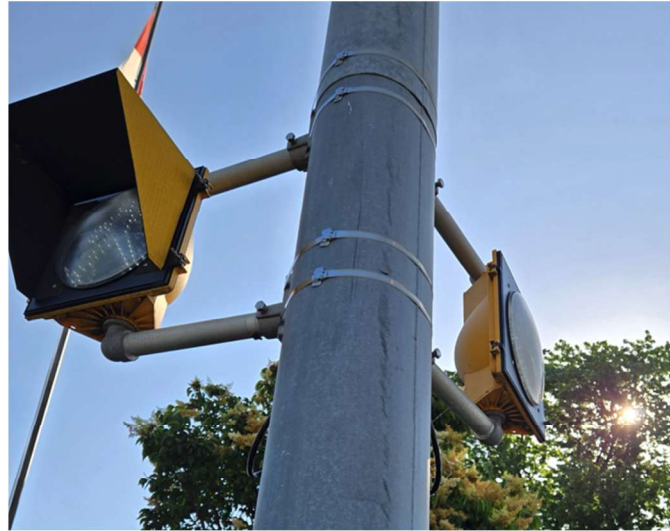
Figure 34: Pedestrian Signal Heads

- The pedestrian pads on the pedestrian push buttons are worn and the paint on the housing is peeling; however, they are still operating.
- The visor is missing from the pedestrian signal head on the northeast corner of the intersection (Figure 34).
- The detector loops are still functioning; however, are past the end of their normal life.

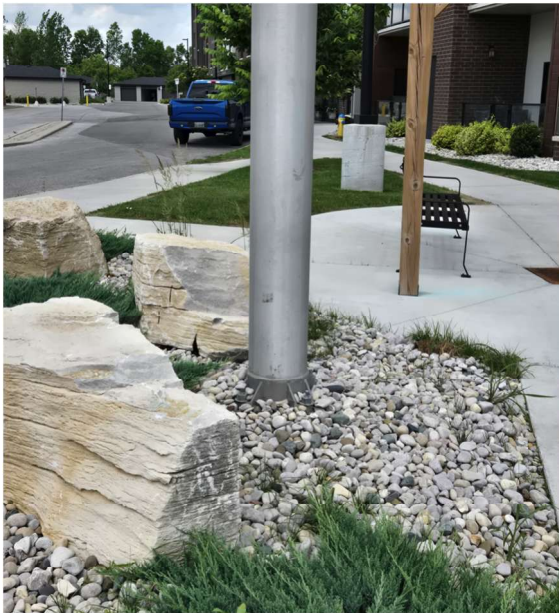
Figure 40: Traffic Pole in Landscaping

The northeast corner of the intersection has built landscaping surrounding the traffic pole (Figure 40). This limits access for maintenance access (larger stones), and they have covered the base of the pole with pebble stones, it is possible that this stone has entered the conduits at the base of the pole, risking damage to the wiring underground and creating electrical faults and potential grounding issues. It is recommended that this landscaping be removed, or the pole be relocated outside of the landscaping.

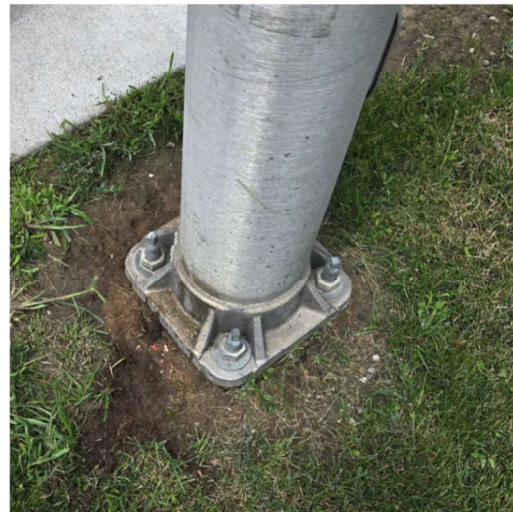
Figure 41: Traffic Pole Base

- This location does not currently have a UPS. While this location is not considered high priority due to traffic volumes on the side street, if the Town's standard is to include a UPS on all traffic signals, one could be added.
- Some poles bases were buried in earth / grass (Figure 41). This can cause early corrosion of the anchor bolts holding the pole. It is recommended to keep the concrete bases exposed.
