# SHUTTLEWORTH DRAIN

E09SH(88)

(Repair and Improvement)

**SHUTTLEWORTH DRAIN  
E09SH(88) - Geographic Twp. of Sandwich South  
Project REI2017D020  
Town of Tecumseh, County of Essex**

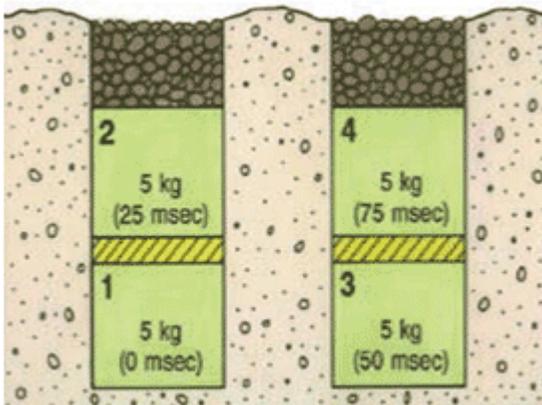
**Figure 1: Sample Blasting Arrangement**

Per Fig. 1: 20 kg total weight of charge; 25 msecs delay between charges and blast holes; and decking of charges within holes.

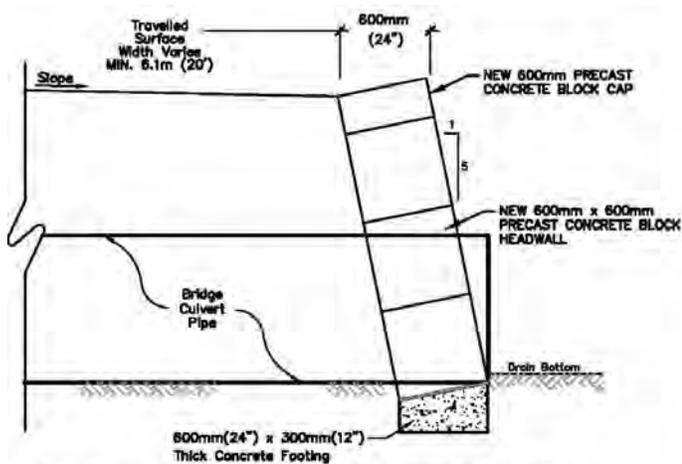
**TYPICAL PRECAST CONCRETE BLOCK END PROTECTION**  
Scale = N.T.S.

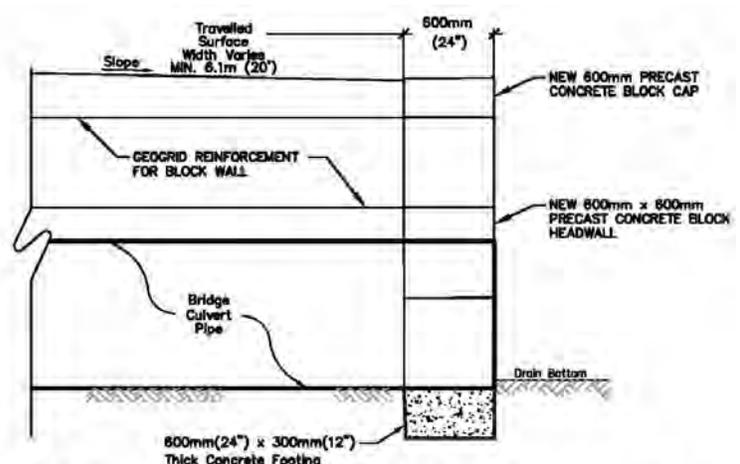
**TYPICAL VERTICAL PRECAST CONCRETE BLOCK END PROTECTION**  
Scale = N.T.S.

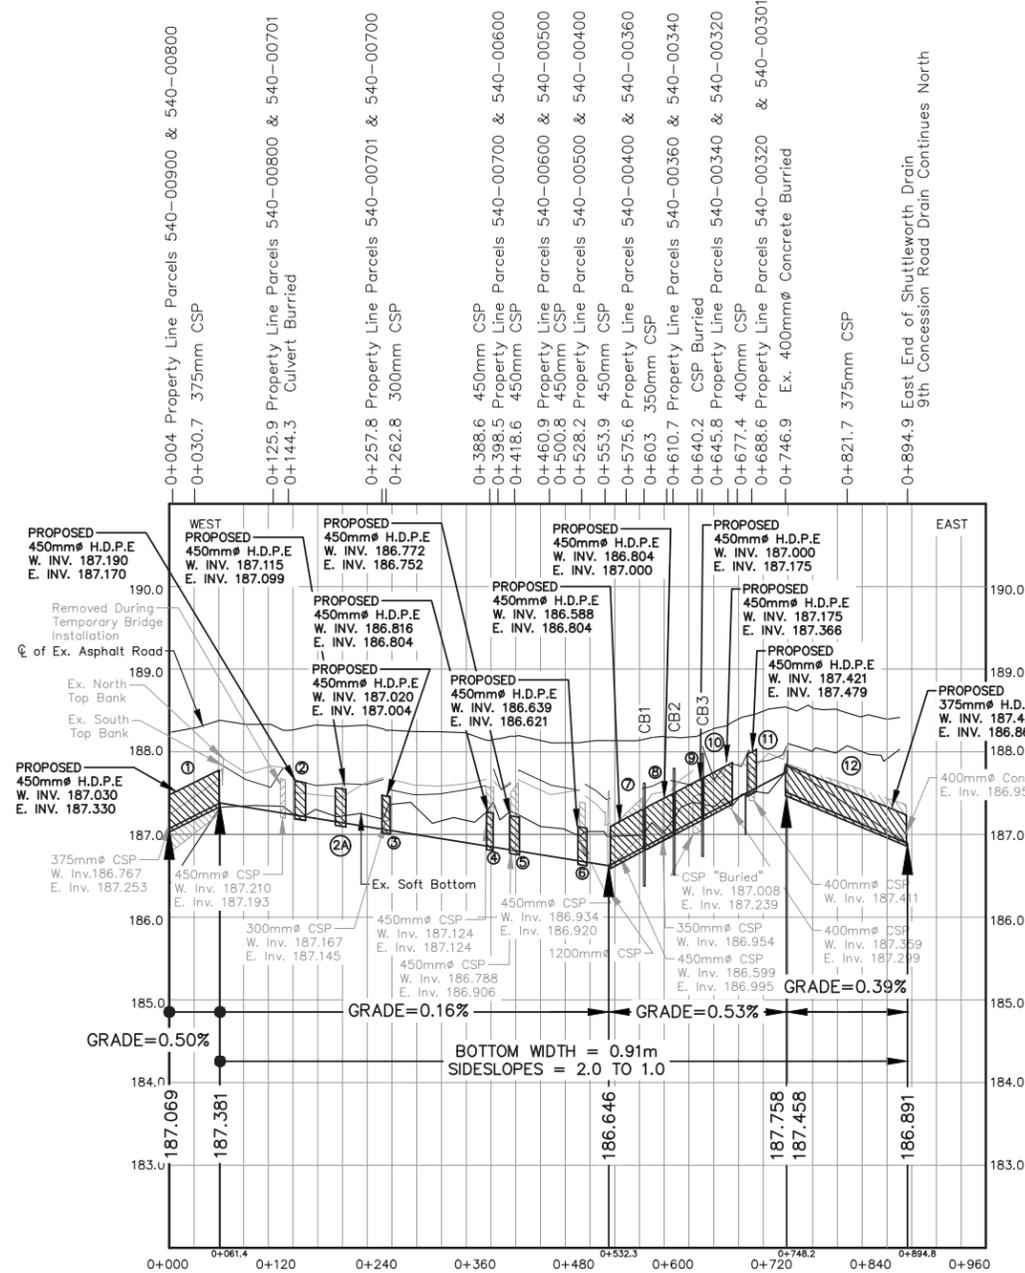
**PROFILE - SHUTTLEWORTH DRAIN**

SCALE=1:5000 hor.  
1:50 vert.

We find that the profile included in the 1967 report plans by engineer C.G.R. Armstrong provides a good fit to the existing west profile of the drain. Said report provided for the construction of the open drain portion that still appears to suit the current conditions of the watershed. Based on our detailed survey, investigations, examinations, and discussions with the affected Owners and governing Authorities, we would recommend that drain improvement works be carried out as follows:

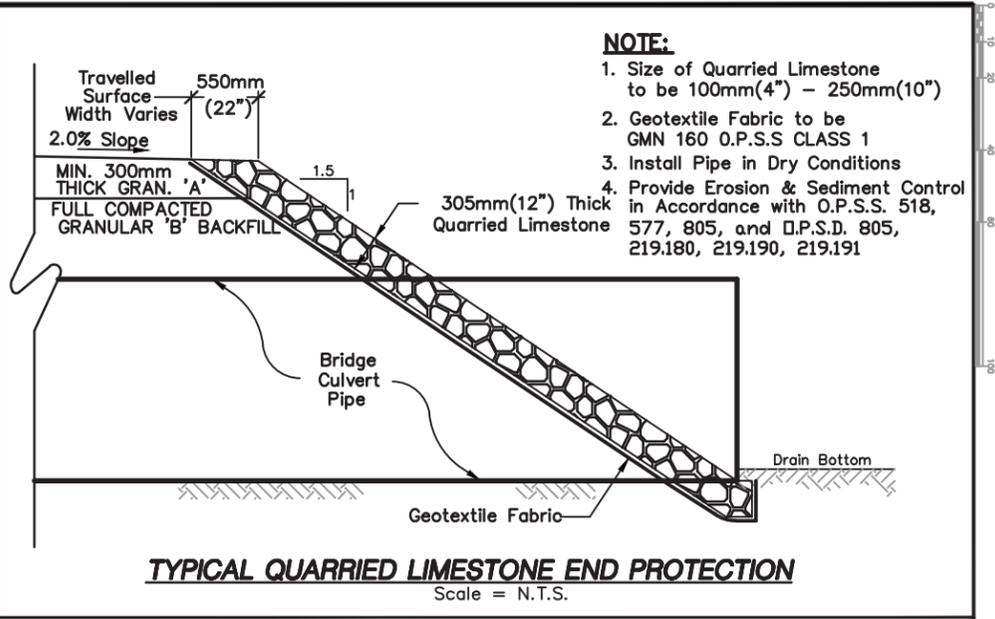
**TYPICAL QUARRIED LIMESTONE END PROTECTION**  
Scale = N.T.S.

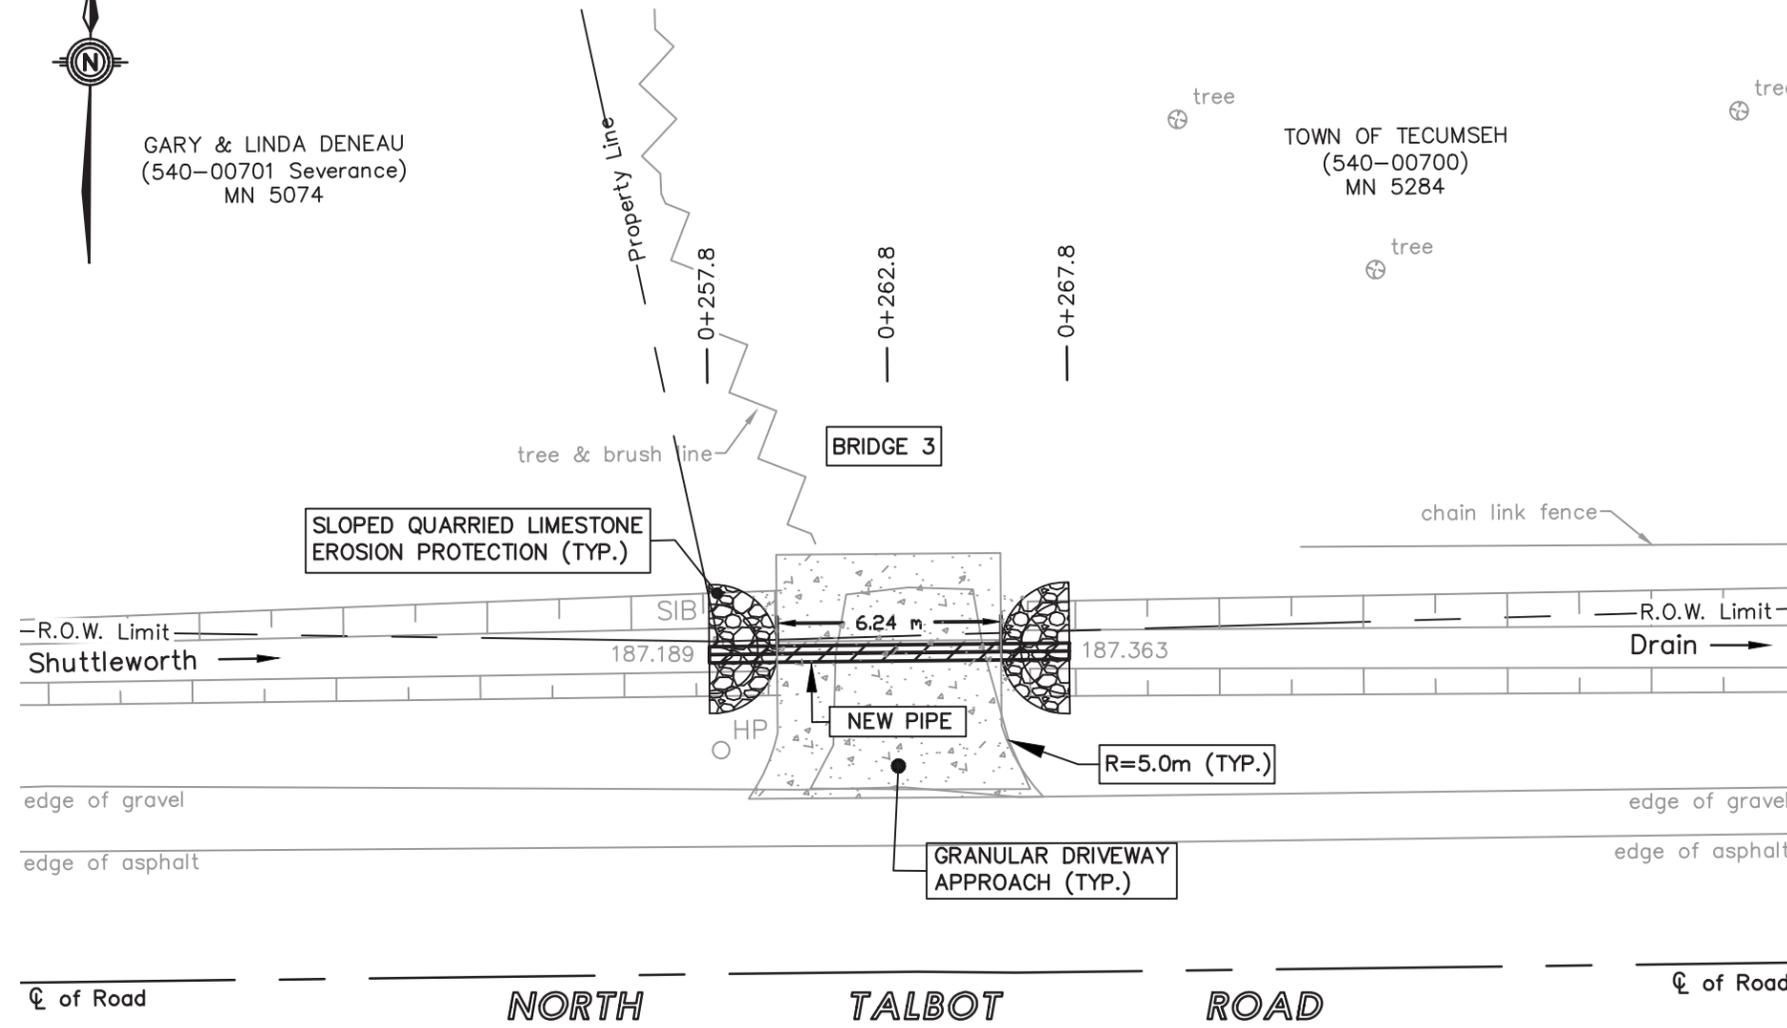
**BRIDGE PLAN**  
SCALE = 1:200

**NOTE:**  
REMOVE EXISTING TREES & BRUSH  
WITHIN NEW BRIDGE INSTALLATION

3. This bridge serves parcel 540-00700 owned by the Town of Tecumseh. The bridge, comprised of C.S.P., is a second access to the property located at its west limit, known as the 'Nature Trail', and is in poor-fair condition. The bridge currently experiences no active headwall protection, typical rusting, and crushed pipe ends. The bridge is to be replaced and should be replaced so that the standard minimum top width of 6.1 metres (20 feet) is provided and the pipe is set to the proposed profile grade of the drain.

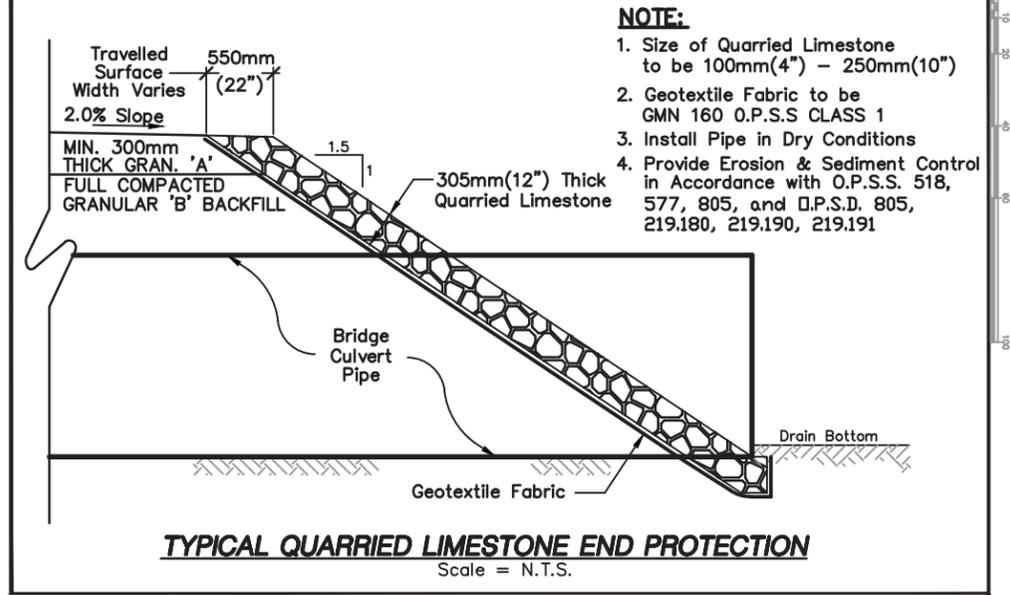
- NOTE:**
1. Size of Quarried Limestone to be 100mm(4") - 250mm(10")
  2. Geotextile Fabric to be GMN 160 O.P.S.S CLASS 1
  3. Install Pipe in Dry Conditions
  4. Provide Erosion & Sediment Control in Accordance with O.P.S.S. 518, 577, 805, and O.P.S.S. 805, 219.180, 219.190, 219.191

**TYPICAL QUARRIED LIMESTONE END PROTECTION**  
Scale = N.T.S.

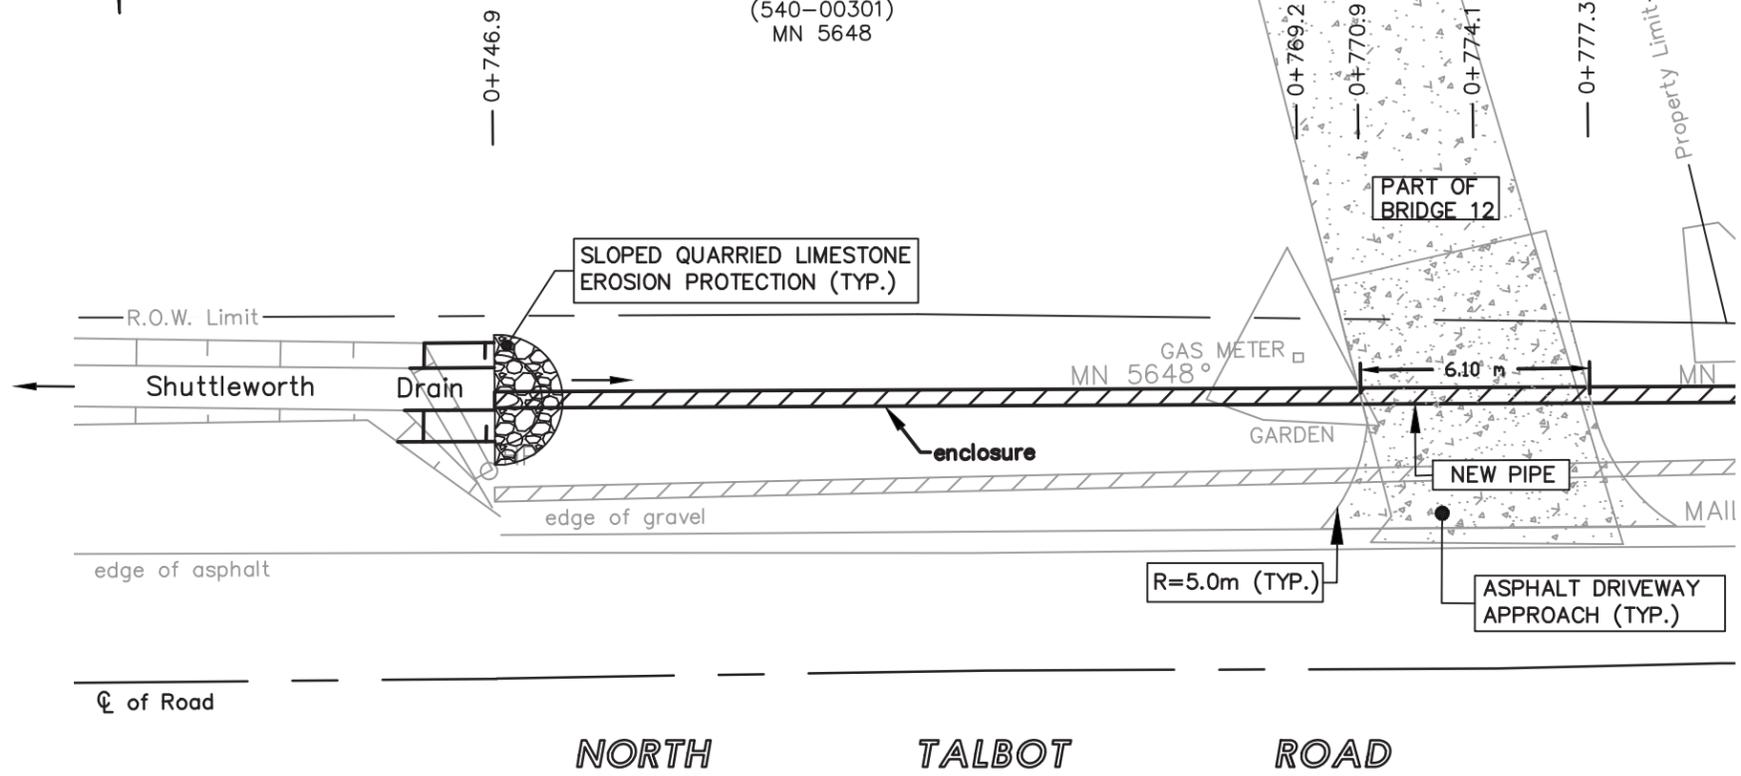
**BRIDGE PLAN**  
SCALE = 1:200

**NOTE:**  
REMOVE EXISTING TREES & BRUSH  
WITHIN NEW BRIDGE INSTALLATION

11. This bridge serves parcel 540-00301 owned by John White. This bridge is a second access to the property near the west limit boundary and is comprised of C.S.P. The pipe experiences the typical associated rusting and is in good condition. The existing pipe does not meet the minimal diameter requirements and should be removed and replaced so that the new pipe is sized accordingly and set to the new proposed profile grade line of the drain.
12. This bridge enclosure serves the east portion of parcel 540-00301 owned by John White, and all across the other lands being parcel 540-00300 owned by Ian Bristow, parcel 540-00200 owned by Thomas & Debra McGuinness, and parcel 540-00100 owned by Mark & Linda Shafer. The enclosure pipe appears to be in fair condition with no observed problems and can be replaced in the future with the appropriate size pipe under maintenance to the drain.

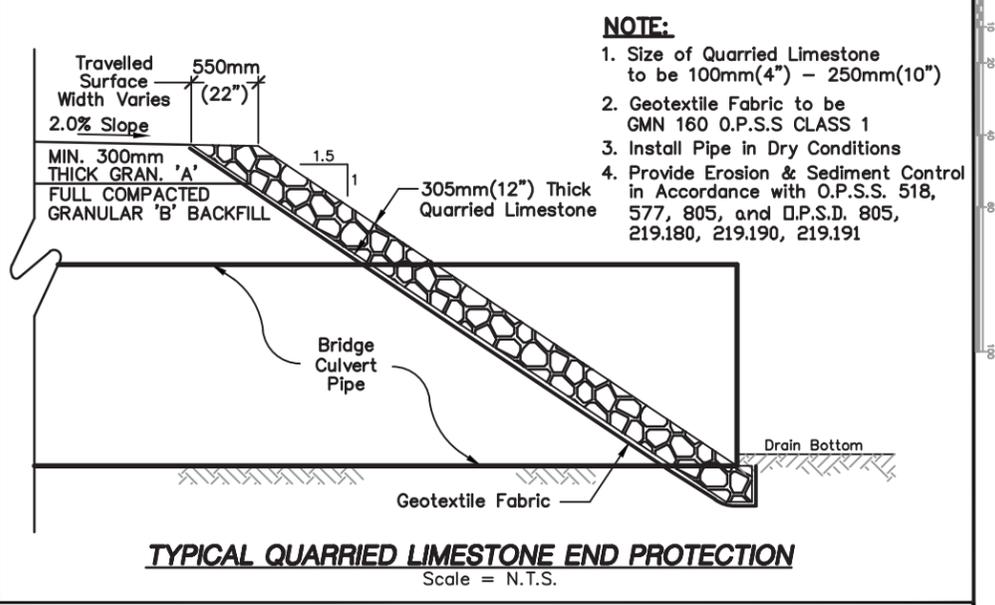
- NOTE:**
1. Size of Quarried Limestone to be 100mm(4") - 250mm(10")
  2. Geotextile Fabric to be GMN 160 O.P.S.S CLASS 1
  3. Install Pipe in Dry Conditions
  4. Provide Erosion & Sediment Control in Accordance with O.P.S.S. 518, 577, 805, and O.P.S.S.D. 805, 219.180, 219.190, 219.191

**TYPICAL QUARRIED LIMESTONE END PROTECTION**  
Scale = N.T.S.
